CHARACTERIZATION AND ASSESSMENT OF THE BEDEN BROOK WATERSHED

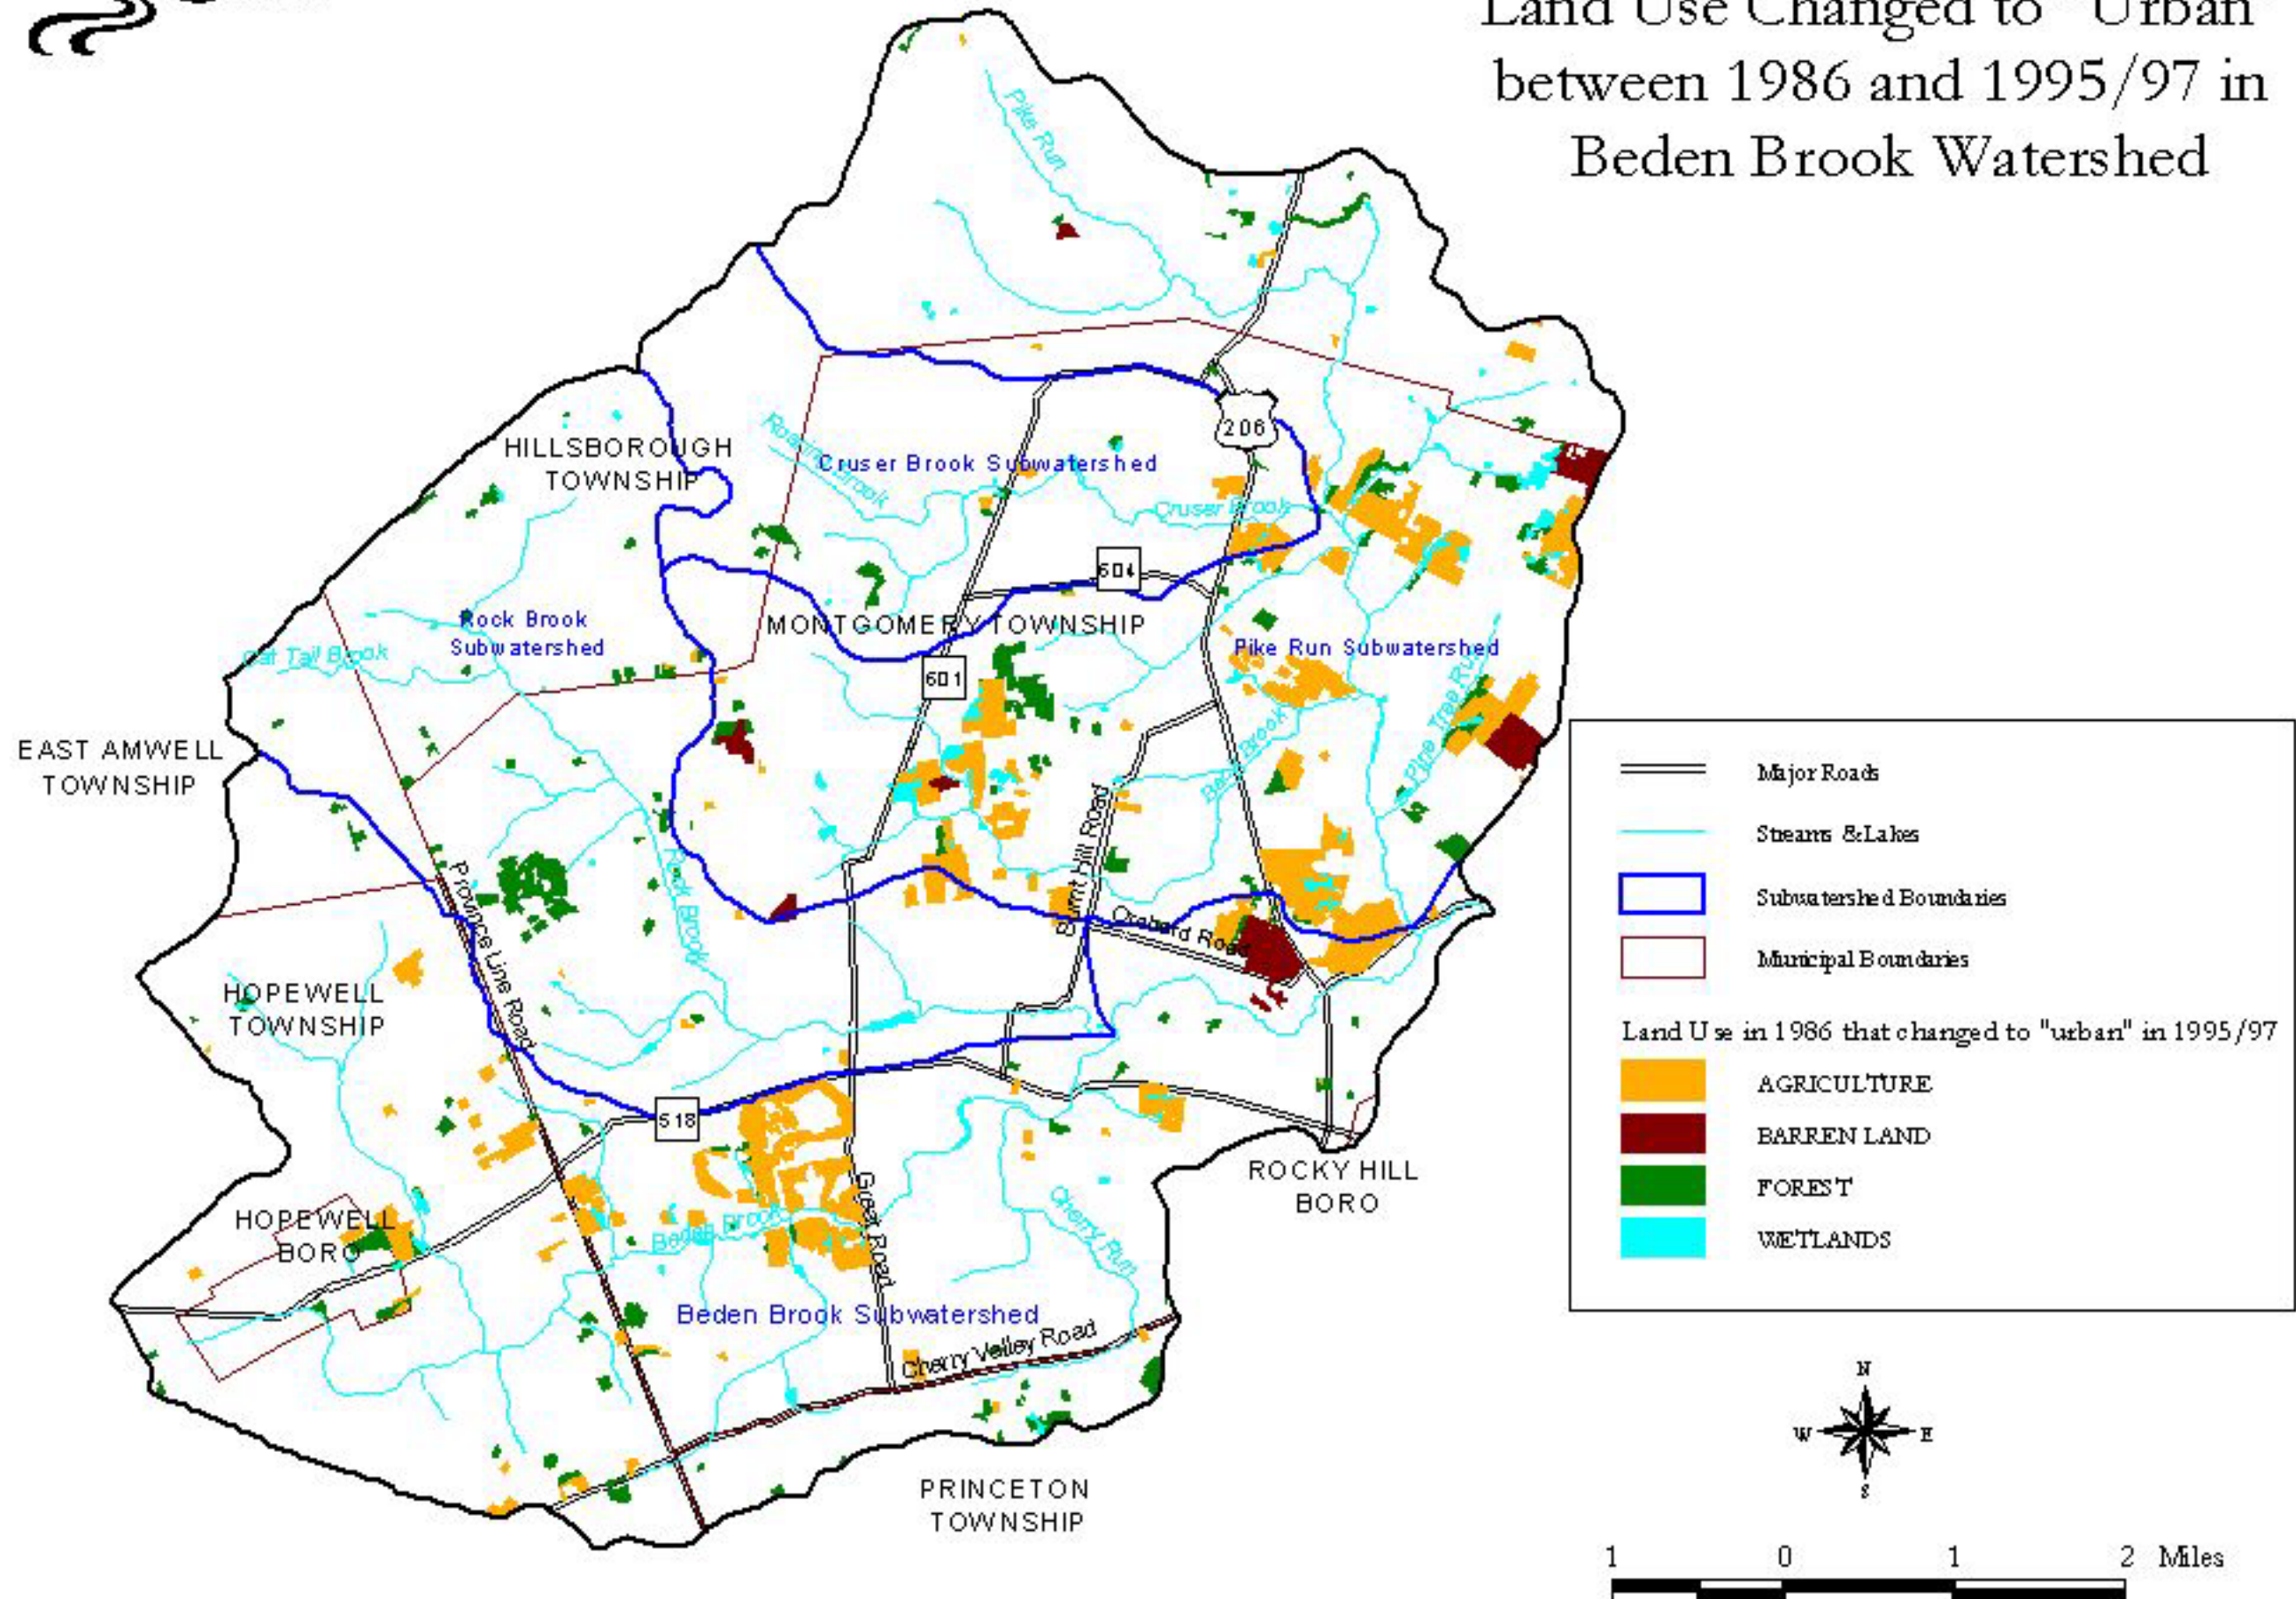
Figure 14
Land Use Changed to "Urban"
between 1986 and 1995/97 in
Beden Brook Watershed

- ◆ Agricultural areas are being lost to suburban development throughout the watershed. Between 1986 and 1995/97, 1,702 acres of land were converted to urban land.

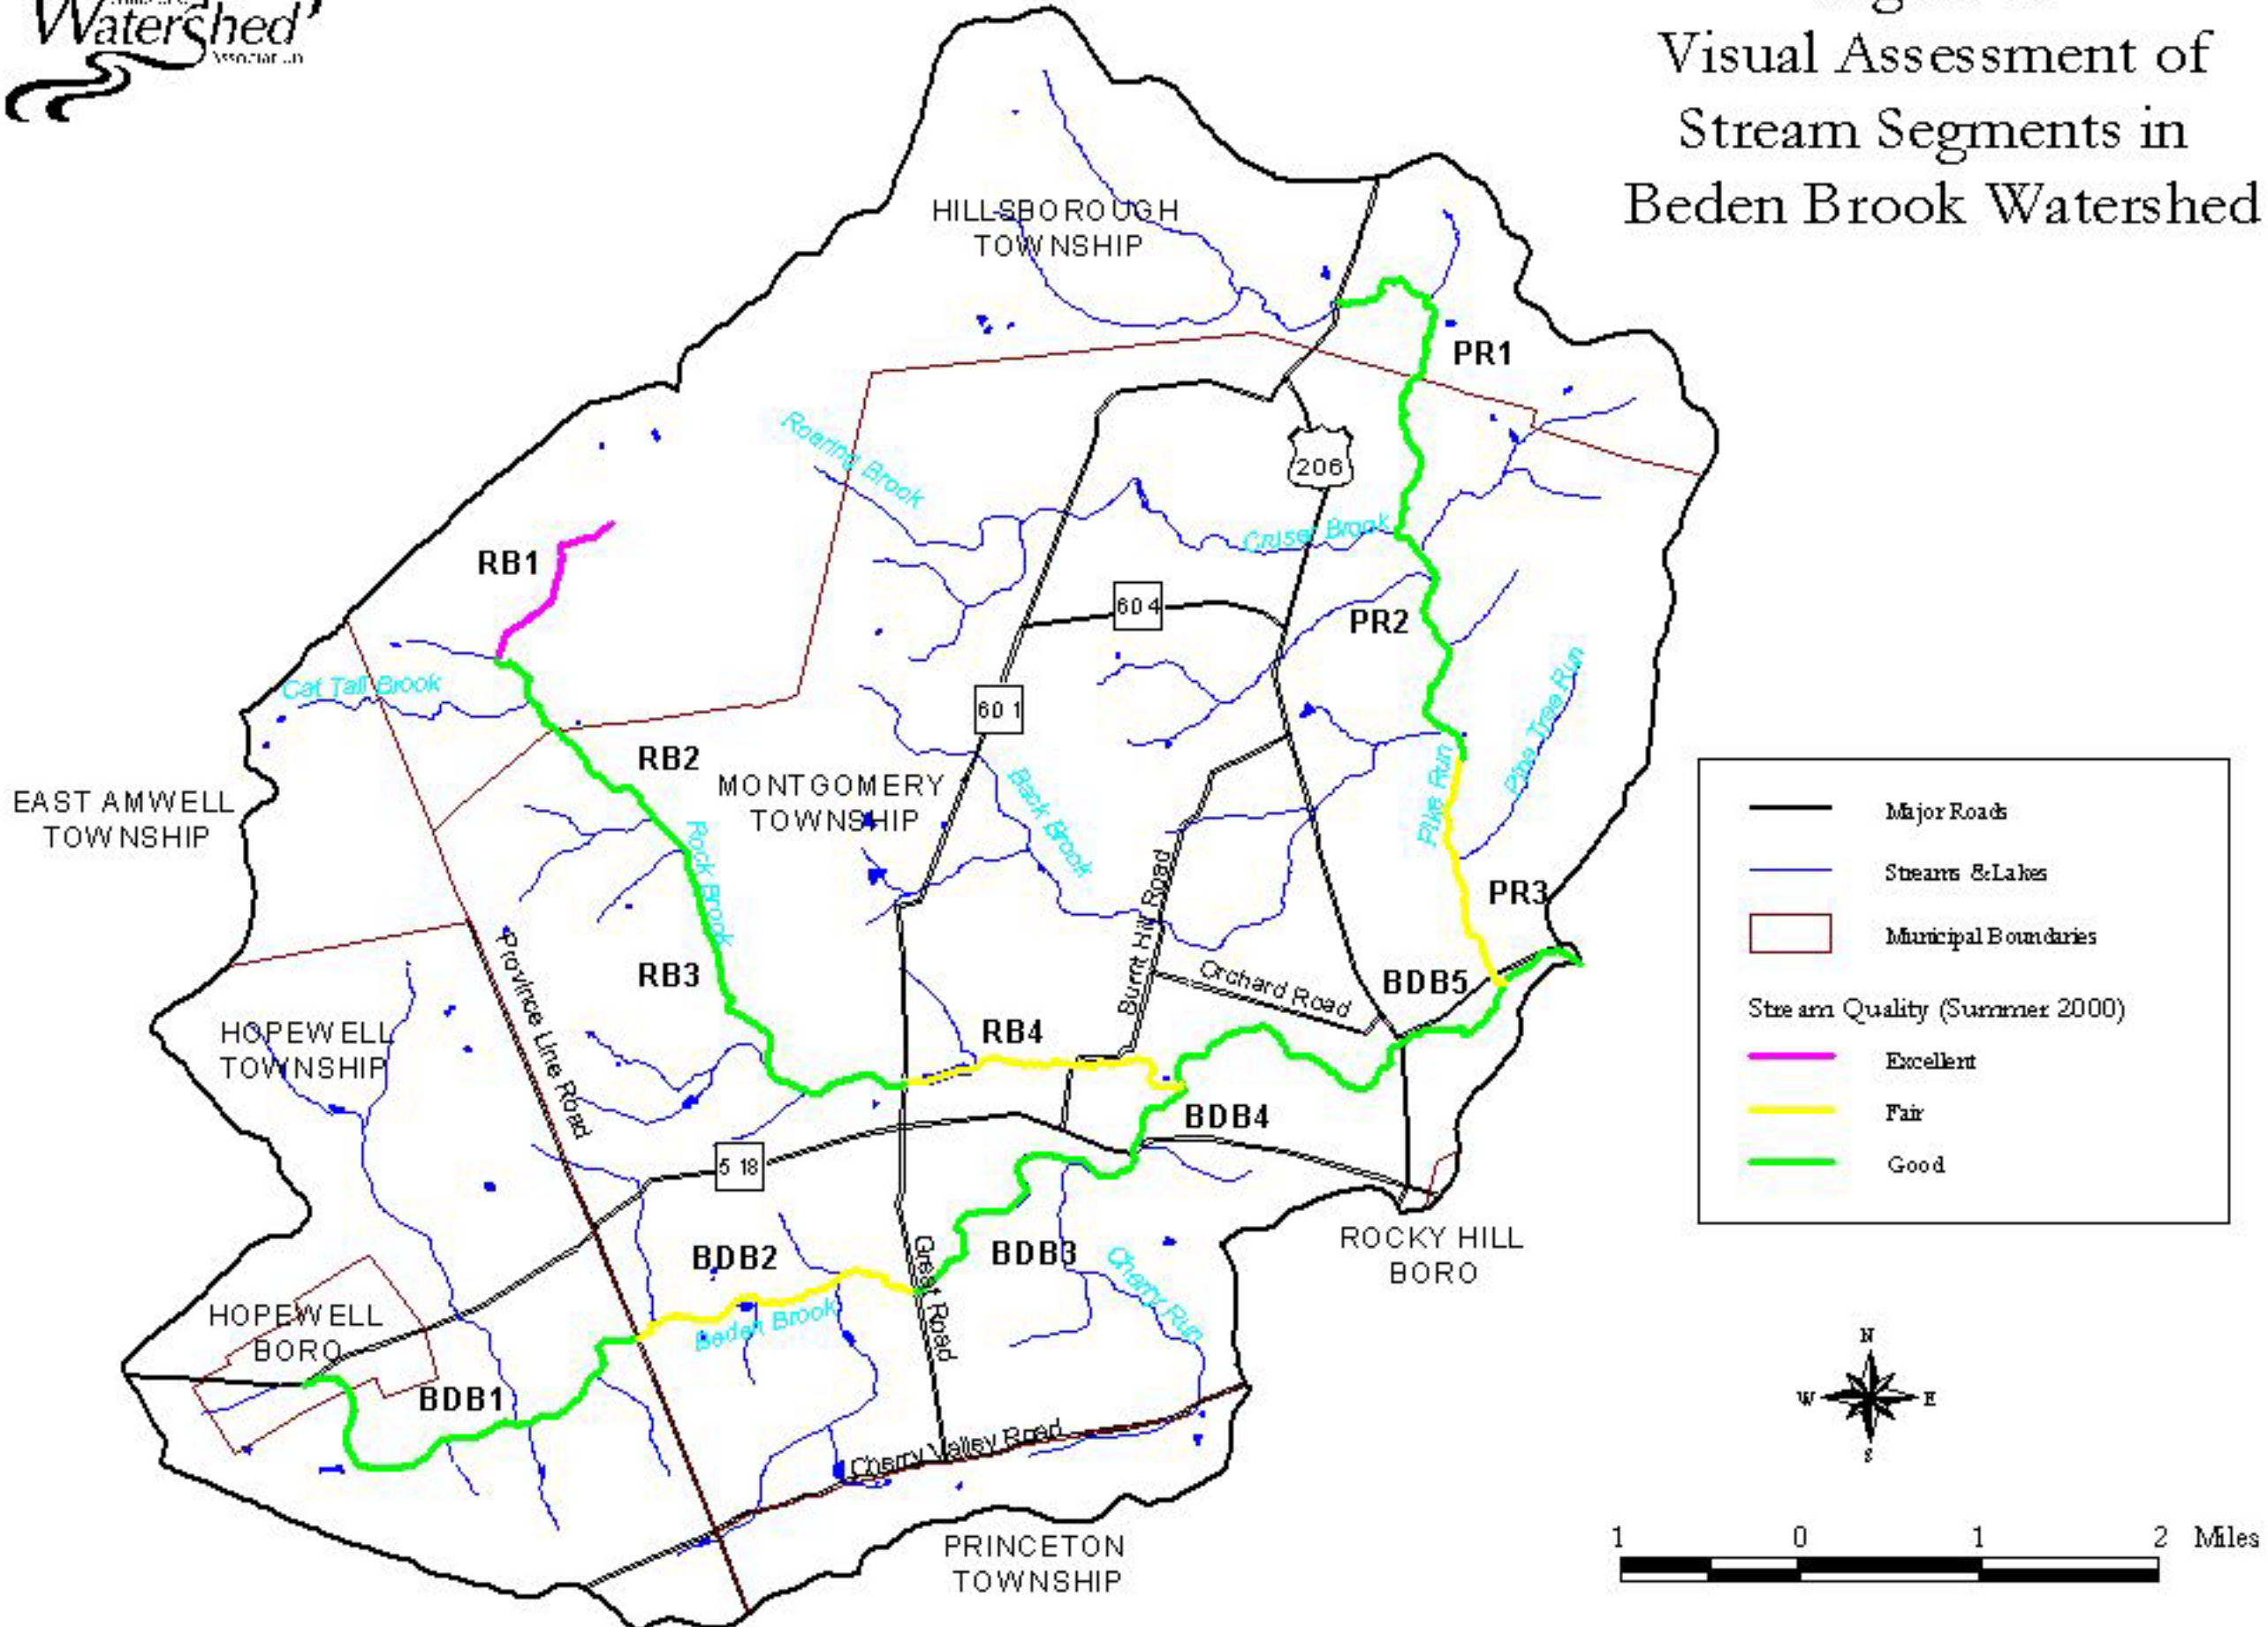
Figure 20
 Visual Assessment of
 Stream Segments in
 Beden Brook Watershed

- ◆ Water quality is degraded along Beden Brook, as evidenced by increasing nutrients, moderate impairment to the macroinvertebrate community, and the lowest rated visual assessment for the stream segment from Province Line Road to the Great Road. The surrounding land uses for that stretch of Beden Brook are directly impacting the water quality as well as quantity.

— Major Roads
 — Streams & Lakes
 — Municipal Boundaries
 Stream Quality (Summer 2000)
 — Excellent
 — Fair
 — Good
