CHARACTERIZATION AND ASSESSMENT OF THE HEATHCOTE BROOK WATERSHED

Cover Photo: SBMWA bacteria sampling Site HCB7 where Heathcote Brook crosses Mapleton Road in South Brunswick Township

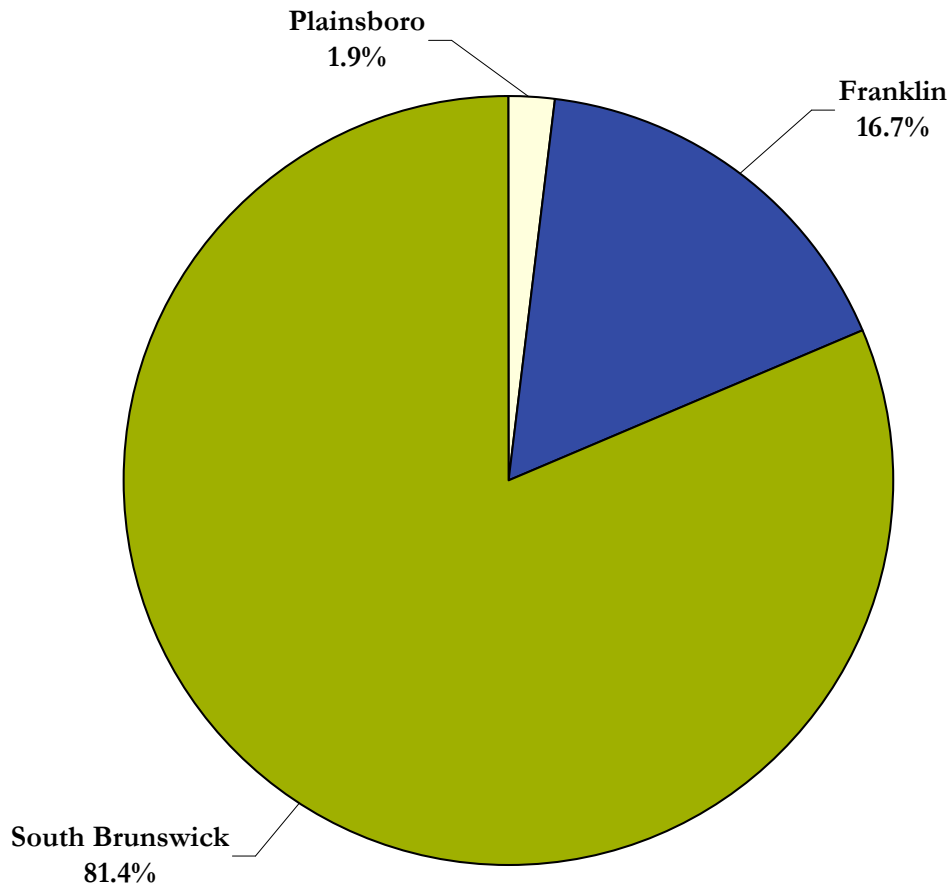
Graph 1: Percentage of the Heathcote Brook Watershed area within each municipality.

Heathcote Brook's headwaters are in South Brunswick Township and flow approximately six miles through Franklin and Plainsboro Townships before meeting the Millstone River just southeast of Route 27 (Figure 2). Carters Brook is one of the major tributaries of Heathcote Brook, but there are also a few smaller tributaries draining into Heathcote Brook (Figure 2). When tributary lengths are included, Heathcote Brook flows a total of approximately 16 miles. Heathcote Brook flows through Reisert Pond and other smaller ponds.

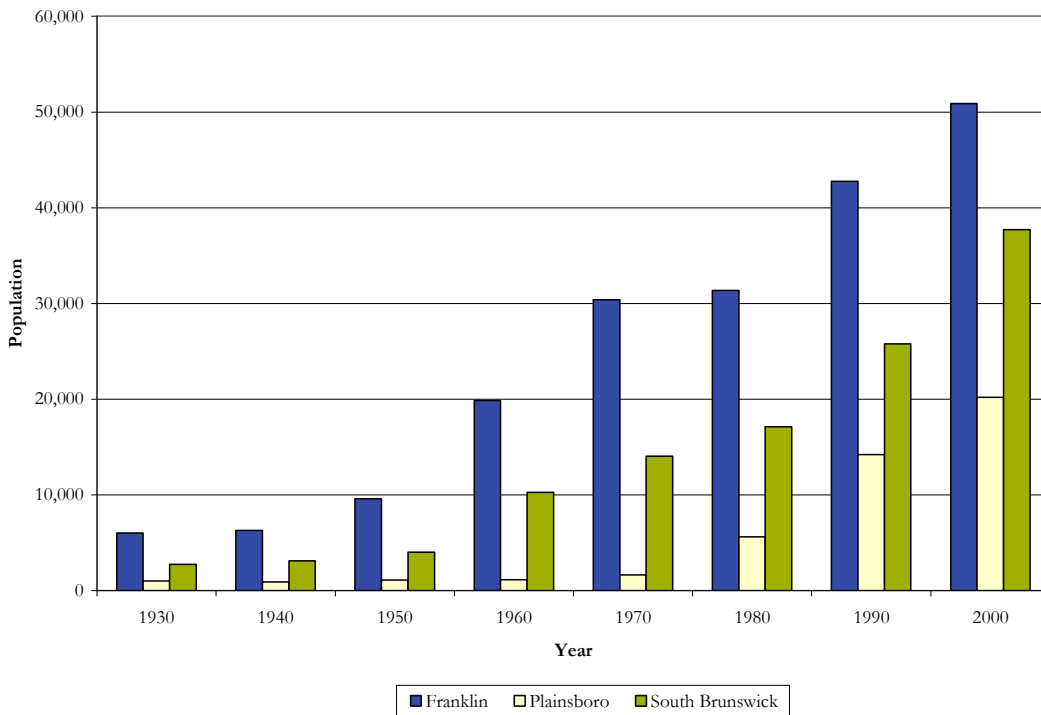
Graph 2: Historical population of the municipalities within the Heathcote Brook Watershed. *

The South Brunswick population increased by 1,268.2% between 1930 and 2000, as it went from 2,758 residents in 1930 to a population of 37,734 in 2000 (Table 2 and Graph 2). South Brunswick contributes a large percentage of the 2000 population (34.7%) for the total population of municipalities found all or partly in the Heathcote Brook Watershed, while contributing to 81.4% of the entire watershed area (Graph 3 and Table 2). With such an increasing population in one municipality that constitutes the largest portion of the Heathcote Brook Watershed, local governance needs to thoughtfully plan out the future direction of development within South Brunswick Township.

A smaller change in population was found in Franklin Township with only a 742.9% increase in population over 70 years (Table 2 and Graph 2). In fact, over the last 30 years, Franklin gained 20,514 residents while South Brunswick gained 23,676 residents in that same time period (Table 3). Franklin may contribute the largest percentage of the 2000 population for the total population of municipalities found within the Heathcote Brook Watershed, 46.8%; however, only 3.3% of Franklin lies within the Heathcote Brook Watershed. Franklin consists of only 16.7% of the entire watershed area.

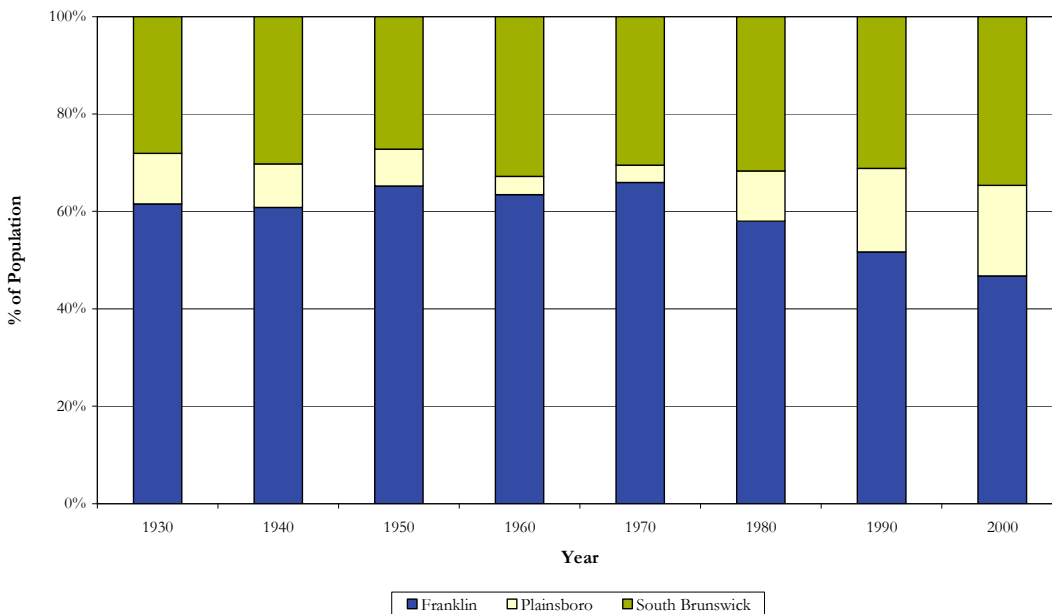
Graph 3: Percentage of total population of the municipalities within the Heathcote Brook Watershed. *

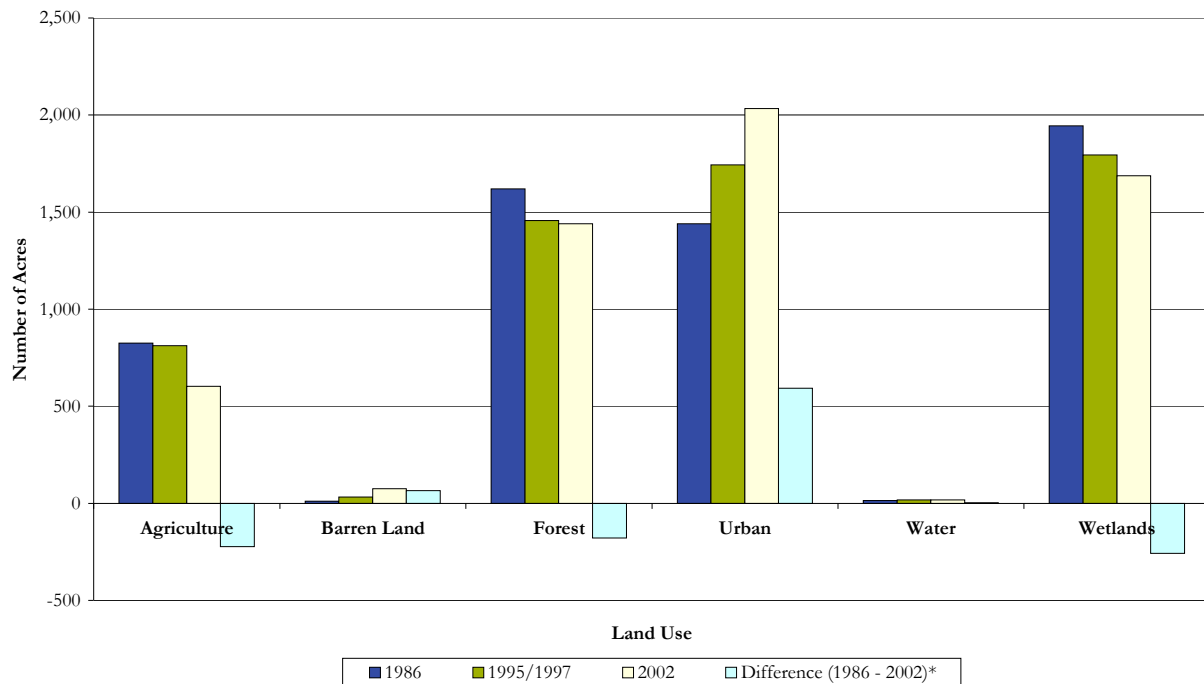
Graph 4: Changes in acreage of land uses in the Heathcote Brook Watershed from 1986 to 2002.

*Negative numbers represent a loss in acreage while positive numbers represent a gain in acreage.

The information for land use comes from the NJDEP land use/land cover data from 1986, 1995/97, and 2002, but much development has occurred within the last five years. Forest, agriculture, urban/developed land, and wetlands will be discussed in more detail, as they make up the majority of land use in the Watershed. The remainder of land use in the Watershed is made up of either water (16.9 acres, or 0.23 % of Heathcote Brook Watershed) in the form of streams, lakes, ponds, reservoirs, and other water bodies; or barren lands (areas characterized by thin soil, sand, or rocks and a lack of vegetative cover in a non-urban setting; 75.1 acres or 1.3% of the Heathcote Brook Watershed) as developing land quarries and mines (Graphs 4 and 5).

In the Heathcote Brook Watershed, land use has changed substantially in the years between 1986 and 2002. There has been a gain in urban area and losses of agricultural lands, forest, and wetlands (Figure 15). Between 1986 and 2002 the landscape draining to Heathcote Brook has changed not only due to shifts in the land use, but also from increases in population and local preservation efforts. For example, Franklin Township preserved two pieces of property (the Lincoln Grove Preserve and John Flemer Preserve) during this time period with the help of the New Jersey Natural Lands Trust. To accommodate the increasing population, forests, wetlands, and agricultural lands are being developed to provide housing and services for new residents. The changes in land use were a loss of 338.2 acres for any land use between 1986 and 1995/97, with 98.9% being contributed by forests, wetlands, and agricultural lands. Between 1995/97 and 2002, 319.4 acres were developed, 90% of which had been forest, wetlands, and agricultural areas. The total loss to development between 1986 and 2002 was 657.6 acres, 94.6% previously consisting of forests, wetlands, and agricultural lands.

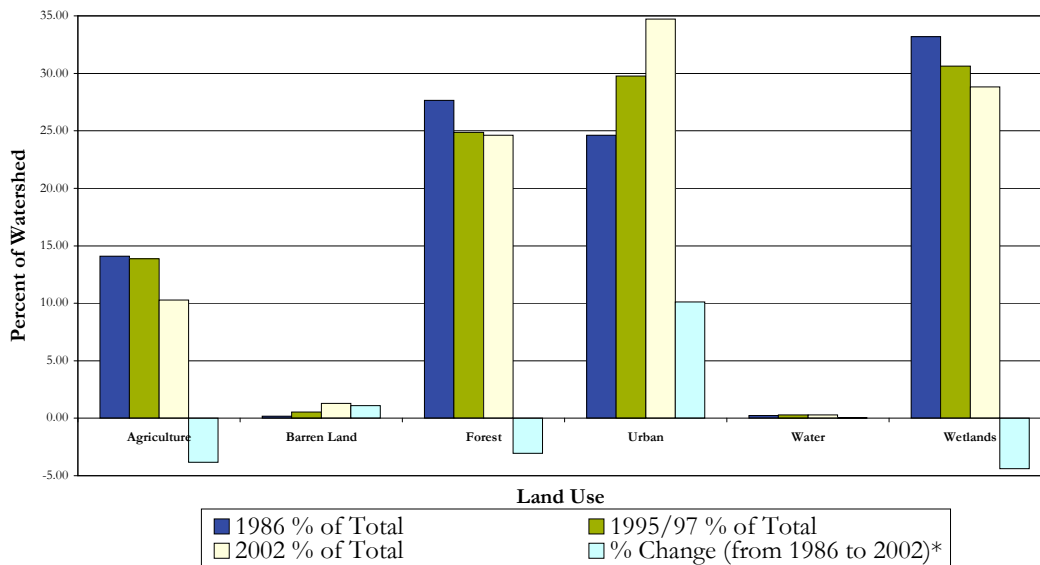
Graph 5: Changes in percent of total watershed area of land uses in the Heathcote Brook Watershed from 1986 to 1995 to 2002.

*Negative percent changes represent a loss in acreage while positive numbers represent a gain in acreage.

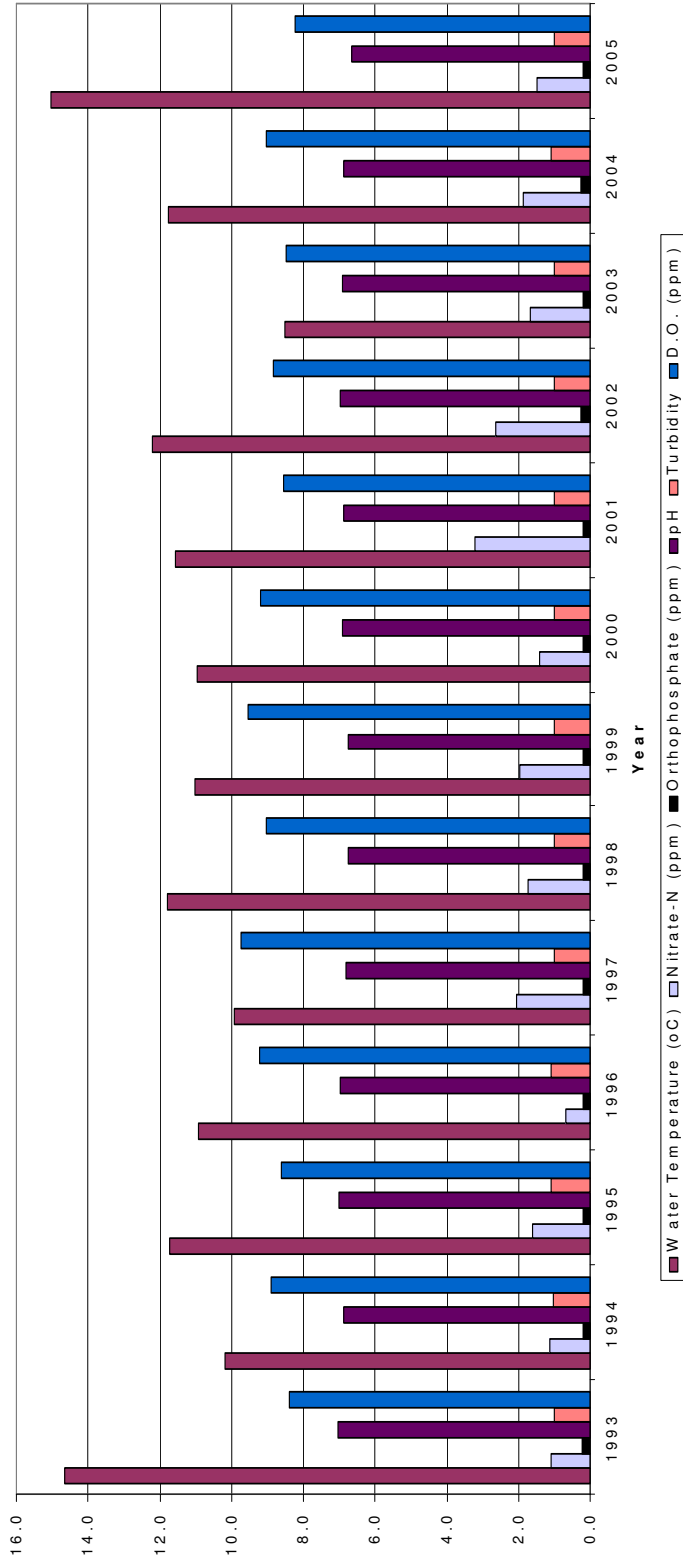
Graph 6: Chemical assessment data for Heathcote Brook (Sites HB1 & HB2) 1993-2005 (SBMWA Data)

Note: pH measured in Standard pH units. Turbidity measured on a scale of 1-7. A result of 1-2 is equivalent to 0-50 NTU

Note: Data represents annual averages for each parameter monitored from 1993-November 2005.

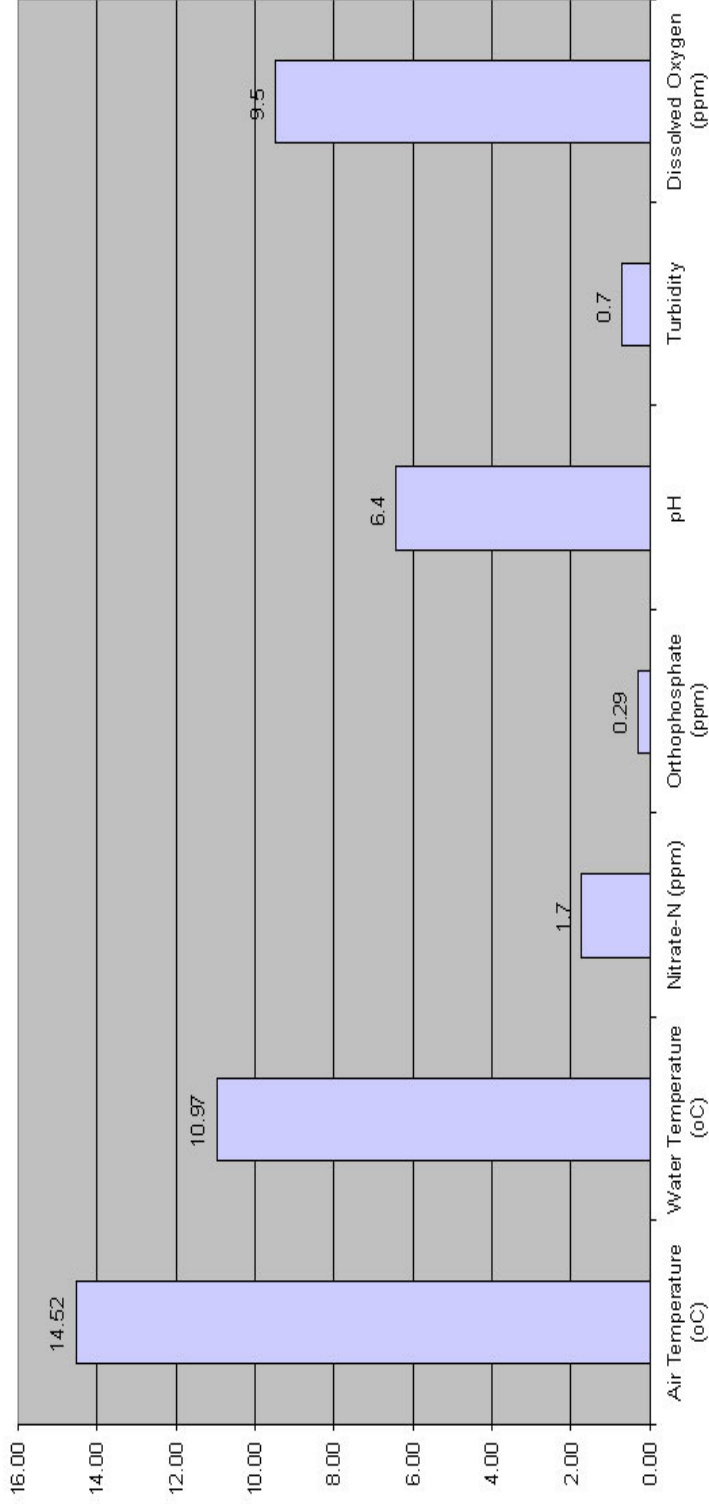
Graph 7: Chemical assessment data for Heathcote Brook (Site HB3) 2005-2007 (SBMWA Data)

Note: pH measured in Standard pH units. Turbidity measured on a scale of 1-7. A result of 1-2 is equivalent to 0-50 NTU
Note: Data represents average value for each parameter monitored from December 2005-September 2007.

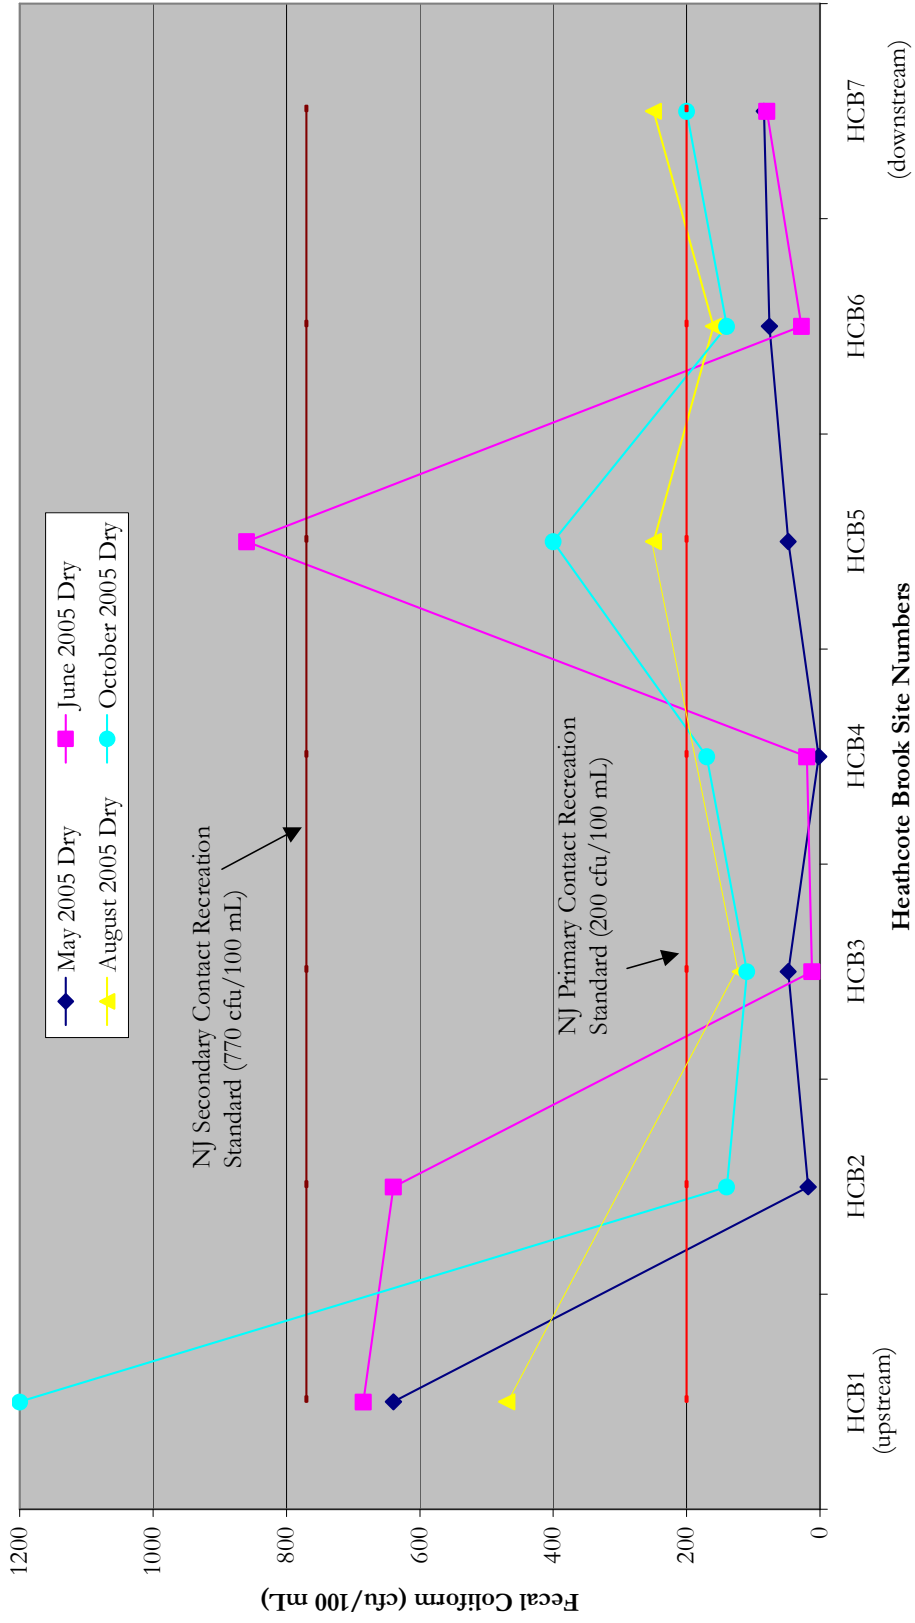
Graph 8: Heathcote Brook 2005 Fecal Coliform Dry Weather Results (SBMWA Data)

These two sites produced the only results in dry weather to violate the boating standard with HCB1 October 2005 results reaching 1200/100 mL

and HCB5 June 2005 results measuring 860/100 mL. Therefore, under dry conditions Heathcote Brook violated the boating standard only 7.7% of the time. Site HCB1 is located in an urban area behind the Red Roof Inn at the intersection of Route 1 South and New Road, just downstream from a trailer park. Site HCB5 is located on Carters Brook, a tributary to Heathcote Brook, behind 11 Carter Brook Lane in Princeton. At this site sewer pipes closely parallel the stream. If these pipes are not properly maintained and are leaking, they could be a potential source of fecal coliform entering the stream.

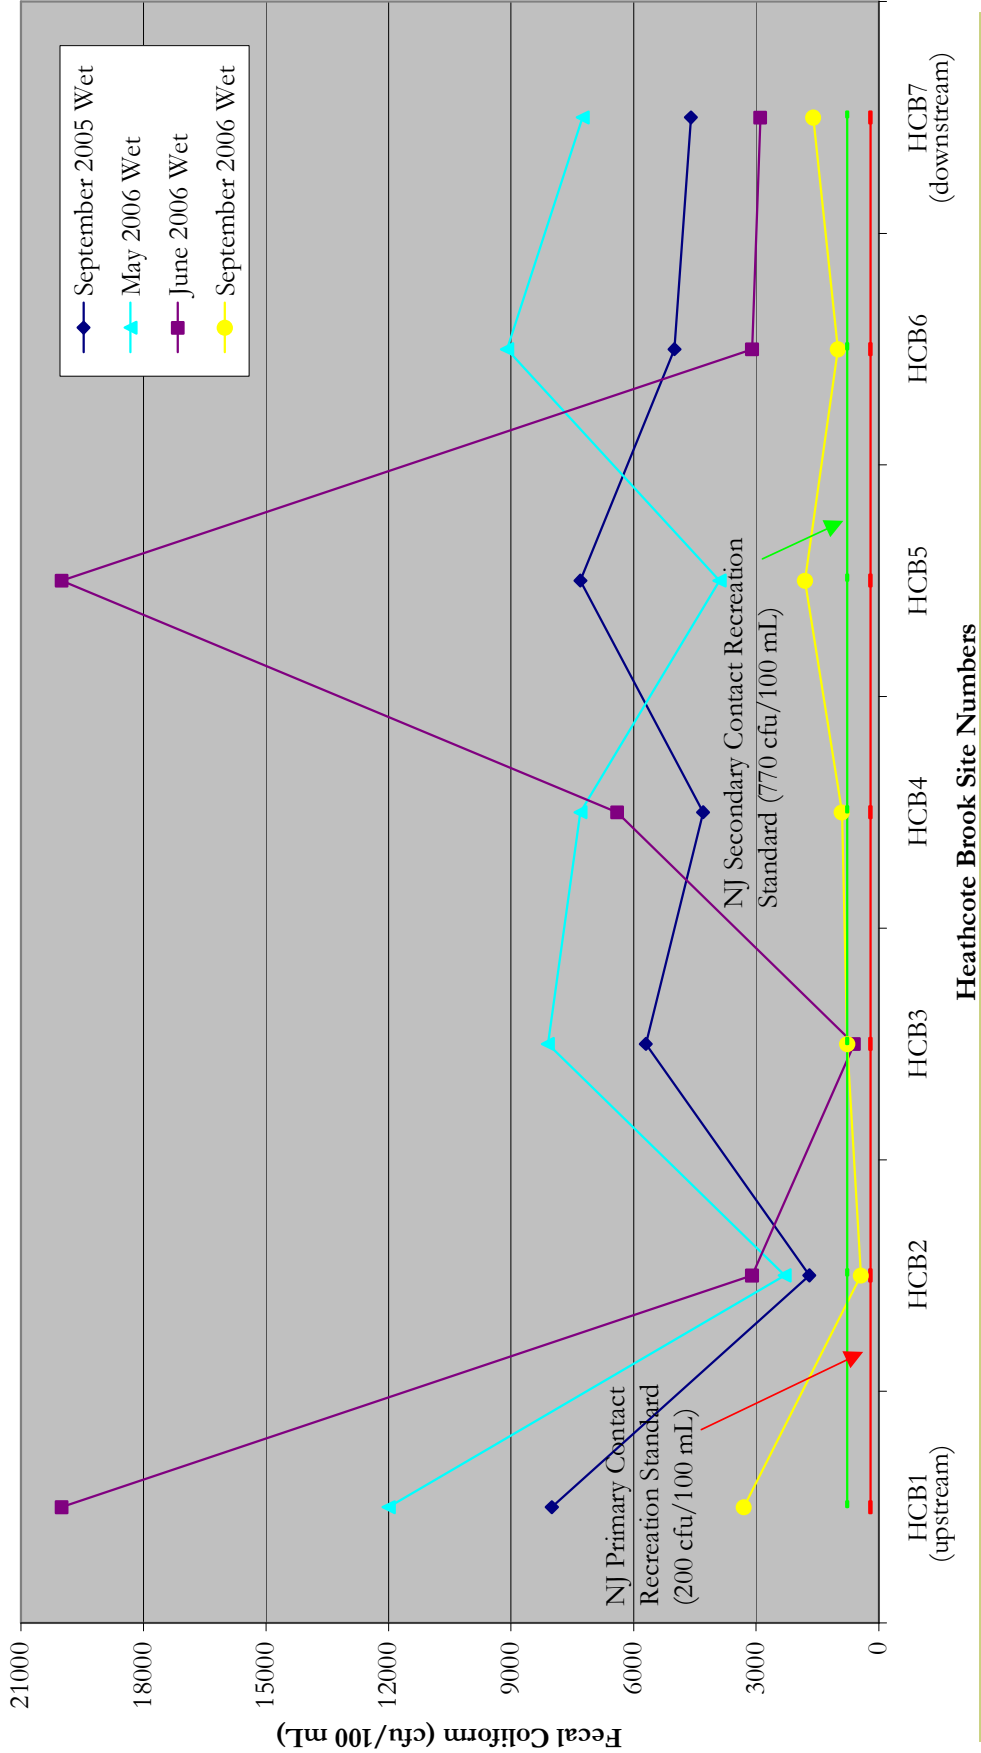
Graph 9: Heathcote Brook Fecal Coliform Wet Weather Results (2005-2006) (SBMWA Data)

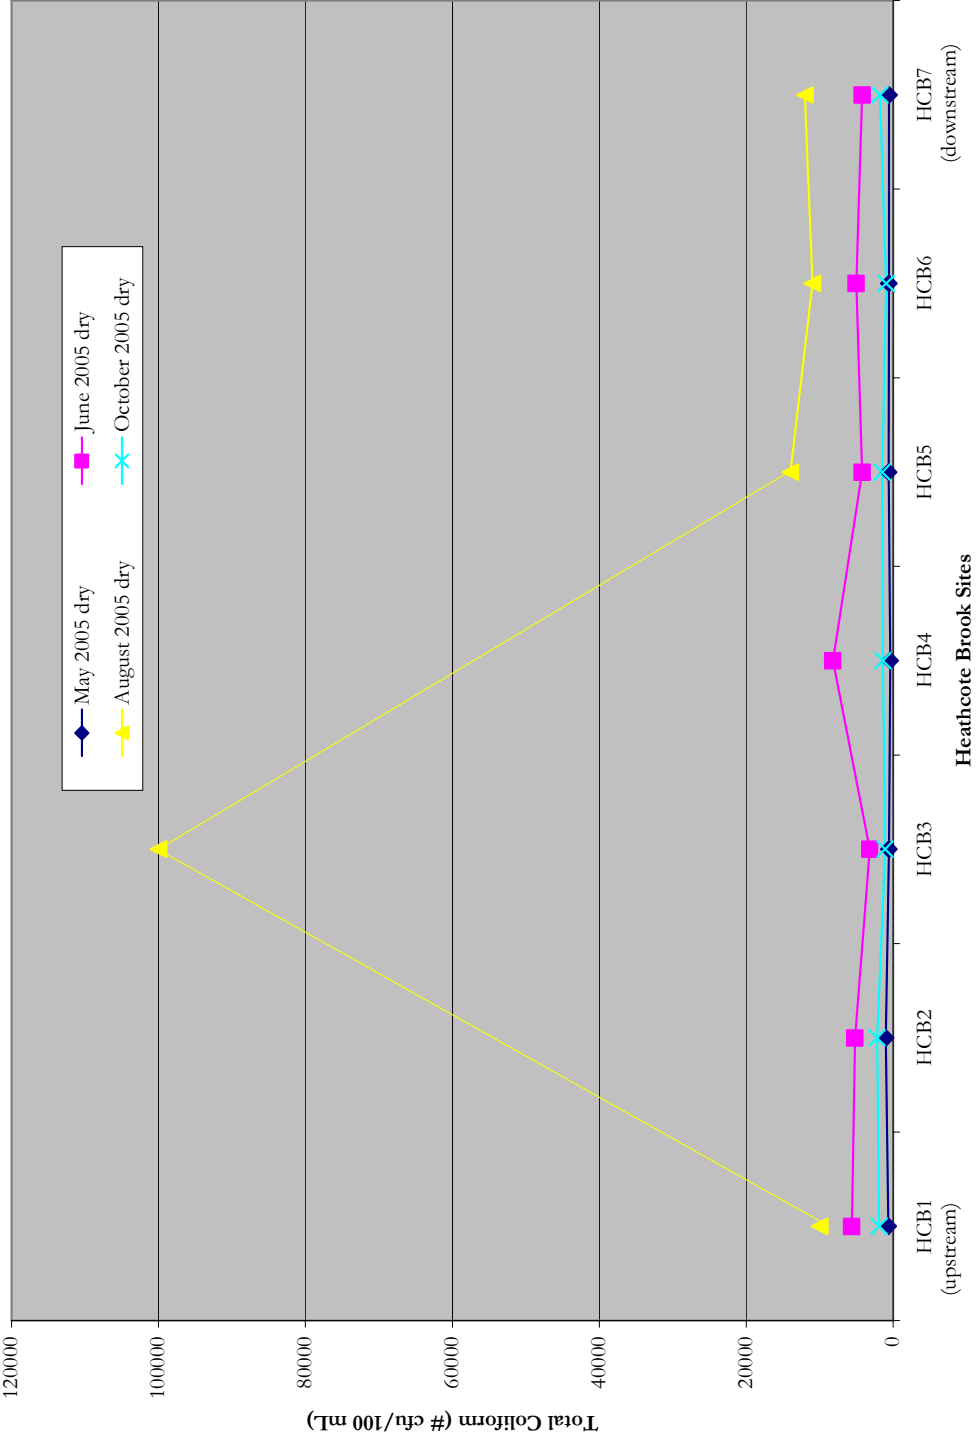
Graph 10: Heathcote Brook 2005 Total Coliform Dry Weather Results (SBMWA Data)

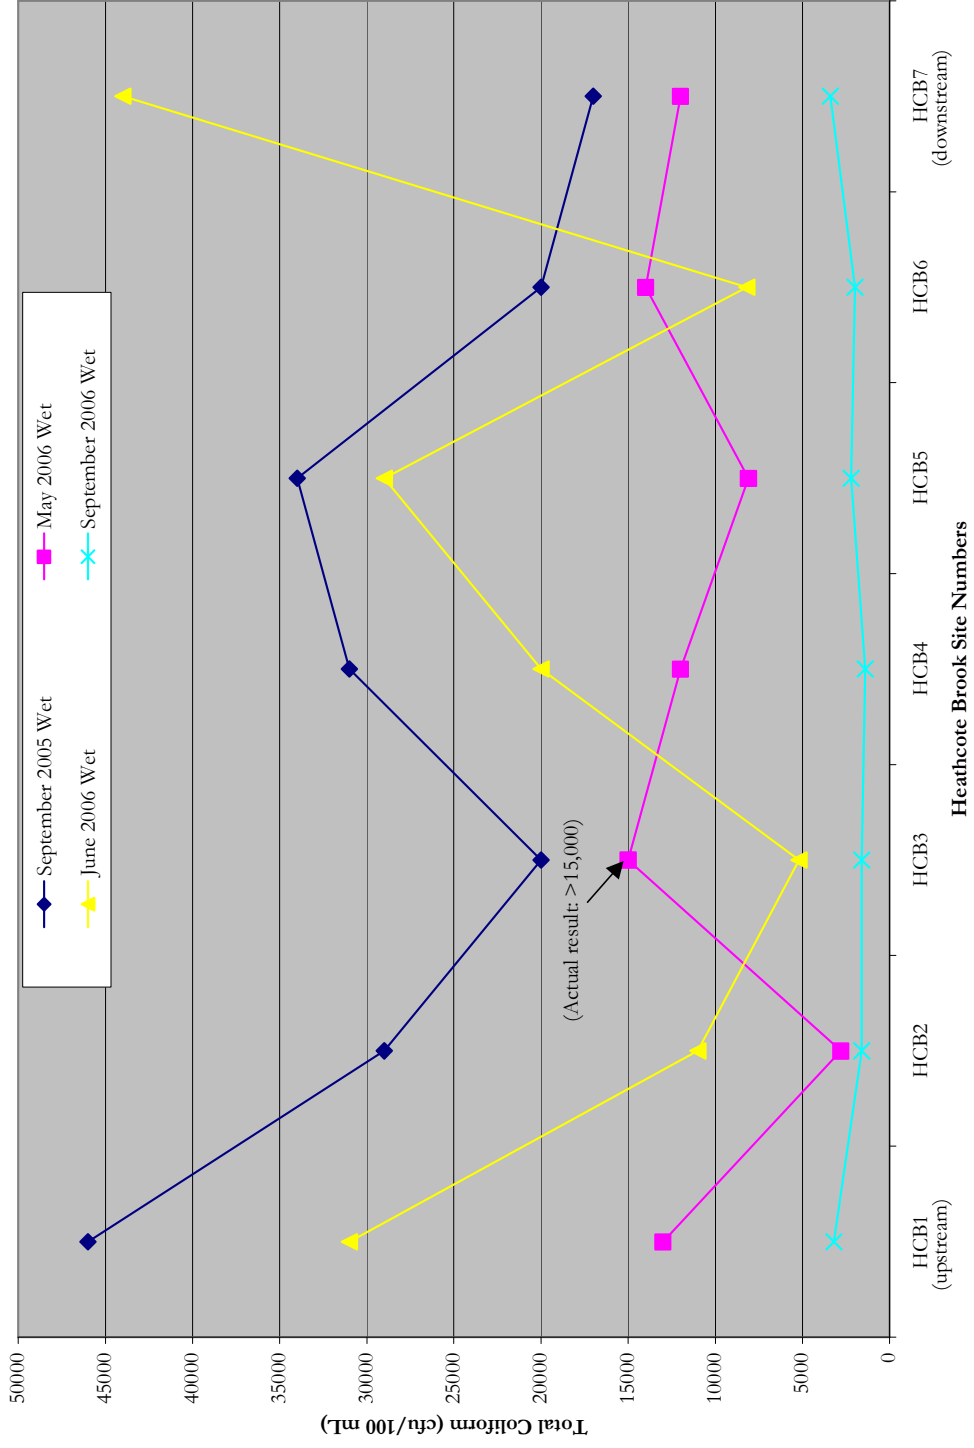
Graph 11: Heathcote Brook Total Coliform Wet Weather Results (2005 - 2006) (SBMWA Data)

Wet weather samples for total coliform were collected between September 2005 and September 2006 (Graph 11). Results ranged from 1,400 cfu/100 mL at Site HCB4 in September 2006 to 46,000 cfu/100 mL at Site HCB1 in September 2005. It should be noted, however, that Site HCB3 results in May 2006 were too numerous to count and are, therefore, unknown. The Lab did not do enough dilutions to accurately measure total coliform results for this analysis, but indicated that the results were at least greater than 15,000

cfu/100 mL. Like the fecal coliform data, the results are generally worst at Sites HCB1 and HCB5. Hourly precipitation data for the wet weather sampling days are included in the attachments.

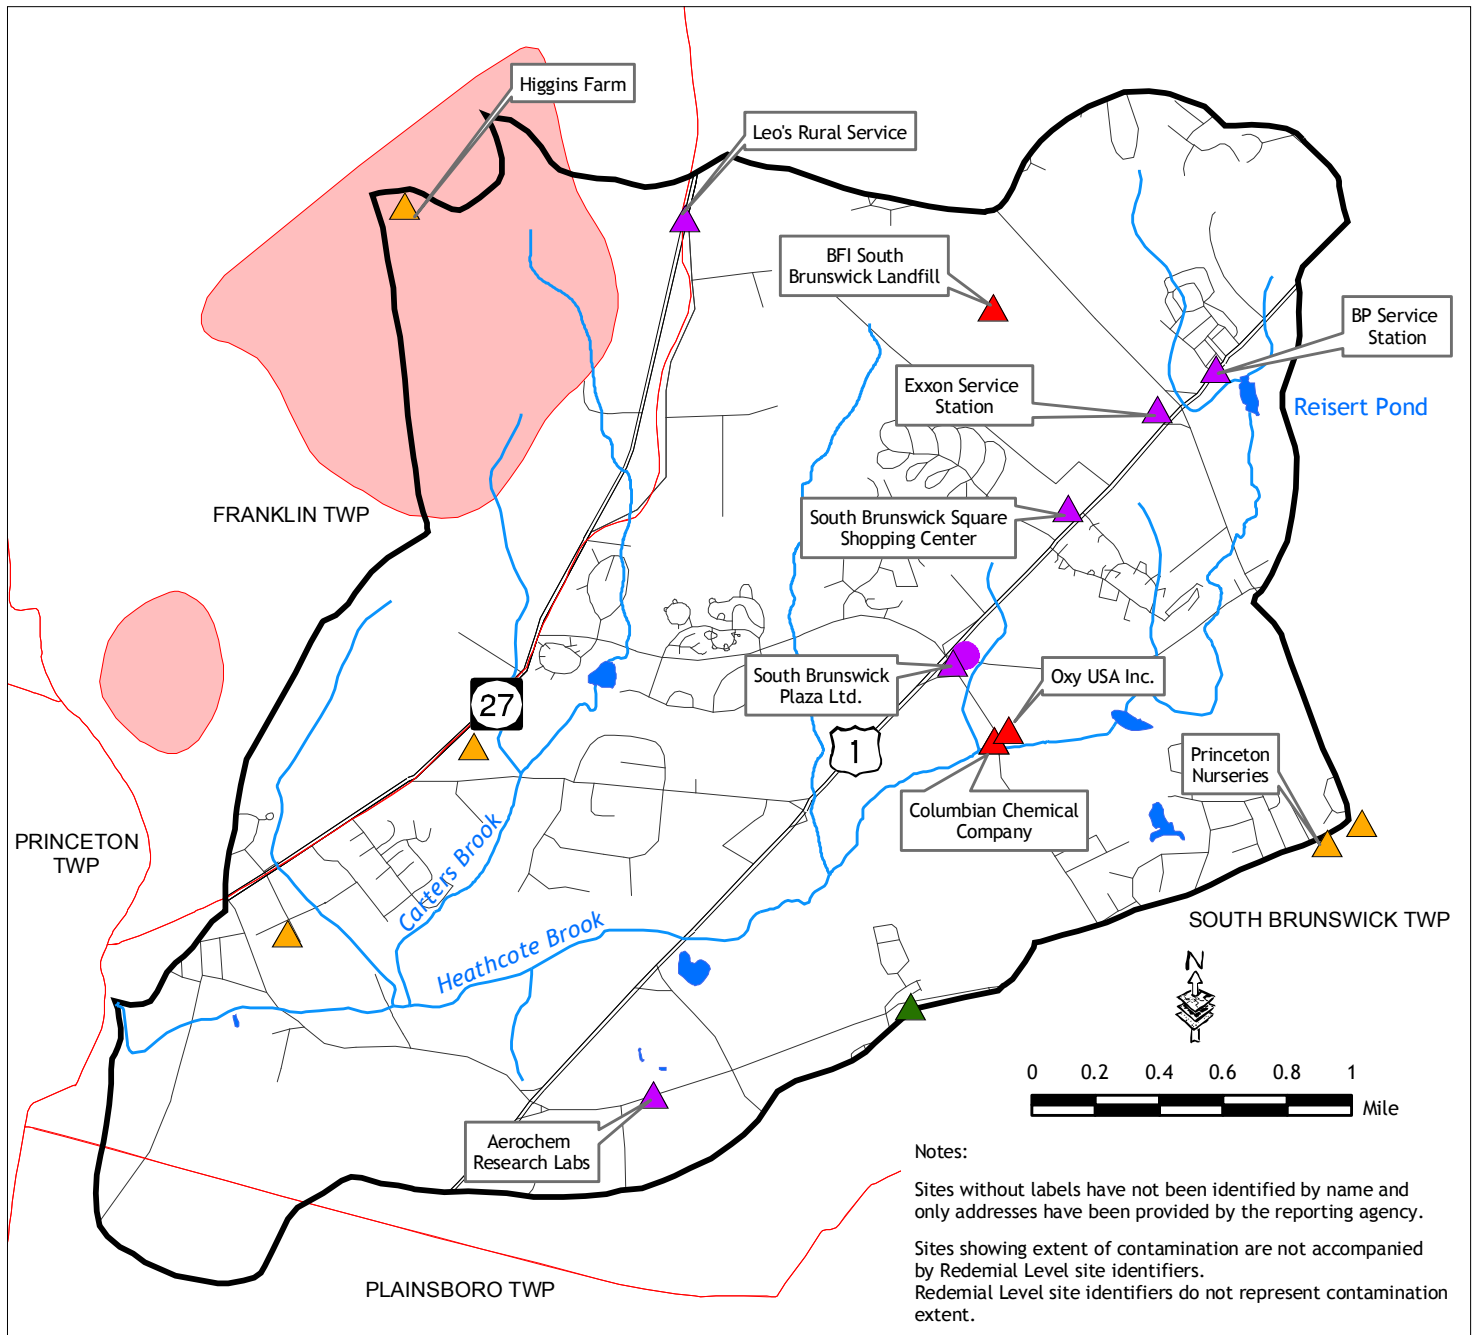
Figure 5: Known Contaminated Sites and Extent of Contamination in Heathcote Brook Watershed

- ▲ B A single phase remedial action with a single contaminant affecting only the soil.
- ▲ C1 Remediation does not require a formal design. The source of the contamination is known or has been identified. There is a potential for ground water contamination.
- ▲ C2 Remediation requires a formal design. The source of the contamination is known OR the release has caused ground water contamination.
- ▲ D A multi-phased remediation with multiple sources/releases to multiple media including ground water.
- ▲ S Should have a Remedial Level but this field was either Blank or designated as "N/A" in Pre-NJEMS data.
- C2 Classification Exception Area

There are currently 13 known contaminated sites (KCSs) in the Heathcote Brook Watershed and two additional sites barely across the northeast watershed border (Figure 5 and Table 6). Four of the 13 KCSs are located along Route 1 and three are located near Route 27 (Figure 5 and Table 6). Twelve of the 13 KCSs are located within the portion of South Brunswick found in the Heathcote Brook Watershed (Figure 5 and Table 6). Known contaminated sites are classified by category and remedial level. All of the KCSs in the Heathcote Brook Watershed are in Category A. Category A sites are those with on-site contamination of soil and/or groundwater. This contamination has been confirmed through sampling and remedial activities are required (NJDEP, 2006a).

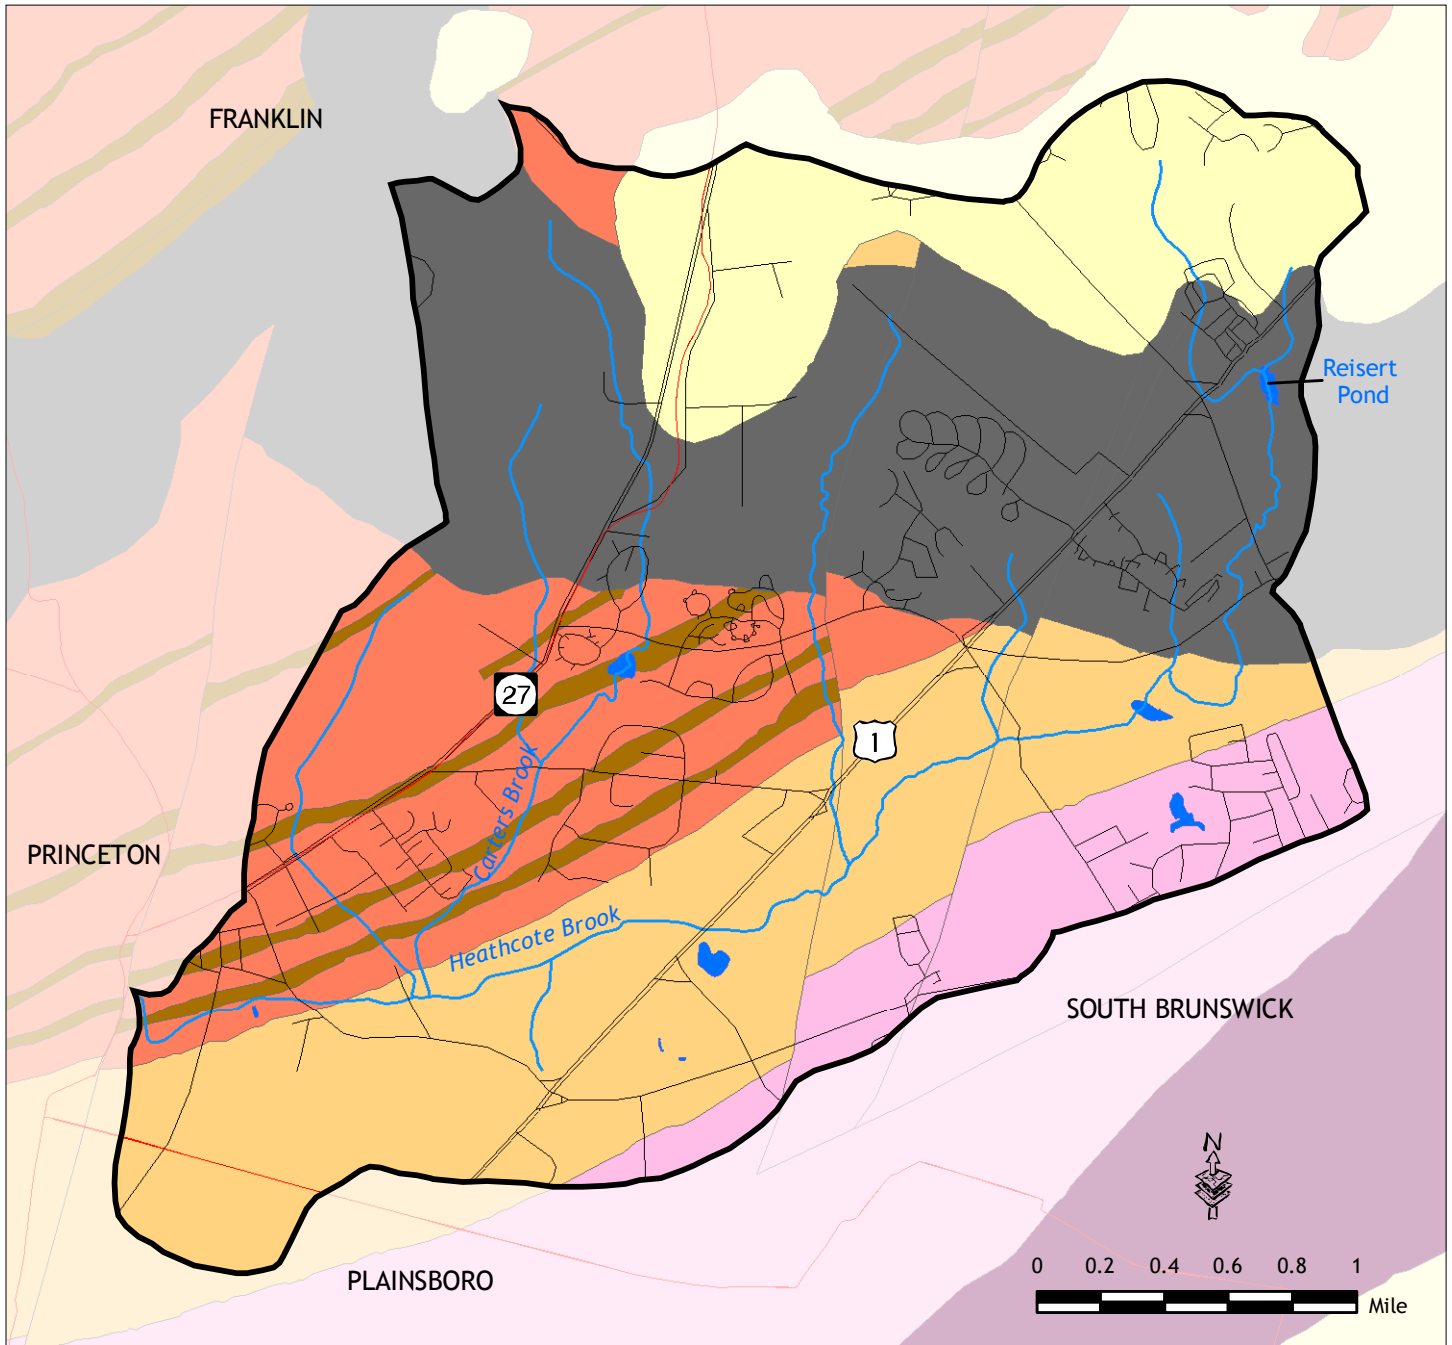
Figure 8: Geology of Heathcote Brook Watershed

Jurassic Diabase: The igneous diabase (trap rock) is a fine-grained to coarse-grained, dark gray to black igneous rock, which has intruded between the beds of the Newark Supergroup sediments. It is extremely hard and resistant to weathering. Forming topographic highs and ridges, the diabase is found, for example, at the top of the Sourland Mountains and is known as the Princeton Ridge (Rogers, Golden, and Halpern, 1995). In the Heathcote Brook Watershed this can be seen running east to west in the upper half (Figure 2) and covers 29% of the watershed.

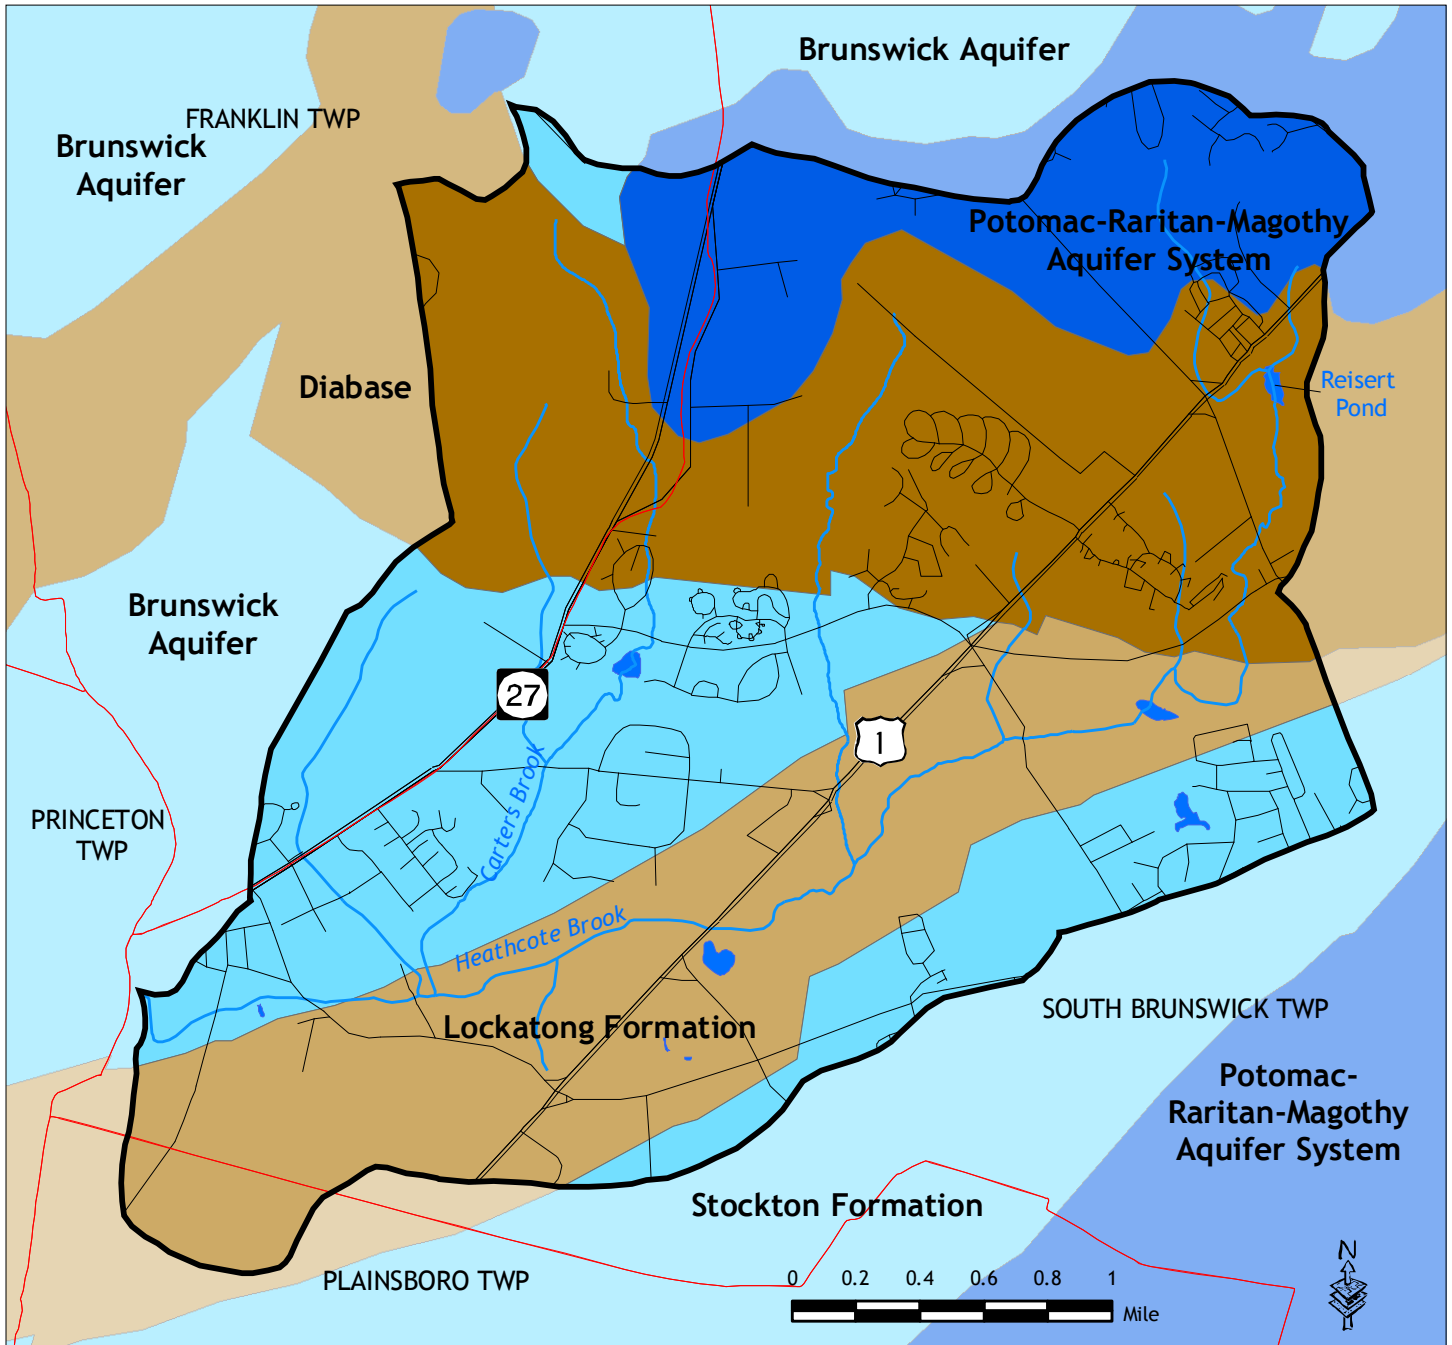
Figure 9: Aquifers of Heathcote Brook Watershed

Magothy Formation (Upper Cretaceous): The sediments of the Magothy are fine- to coarse-grained, locally gravelly, quartz sand, interbedded with thin layers of clay or clay-silt, mostly at the top of the Formation. Minor amounts of muscovite and feldspar occur in the sand, and large wood fragments are found in the clay layers. The Magothy occurs at the surface in the uppermost (northern) portion of the Heathcote Brook Watershed and covers 14% of that area. The sands of the Magothy Formation, together with the usually contiguous Raritan and Potomac Formations seen farther to the southeast in the Millstone watershed, serve as an extensive and regionally very important aquifer system. The Magothy Formation is one of the most vital groundwater resources within the Millstone Watershed and Central New Jersey as well as one of the most susceptible to groundwater contamination because of its widespread exposure, the high sand content, and likely thickness of 60 feet or more (Mulhall, 2004). This formation has the highest average yield from high capacity wells of greater than 500 gal/min (Figure 9).

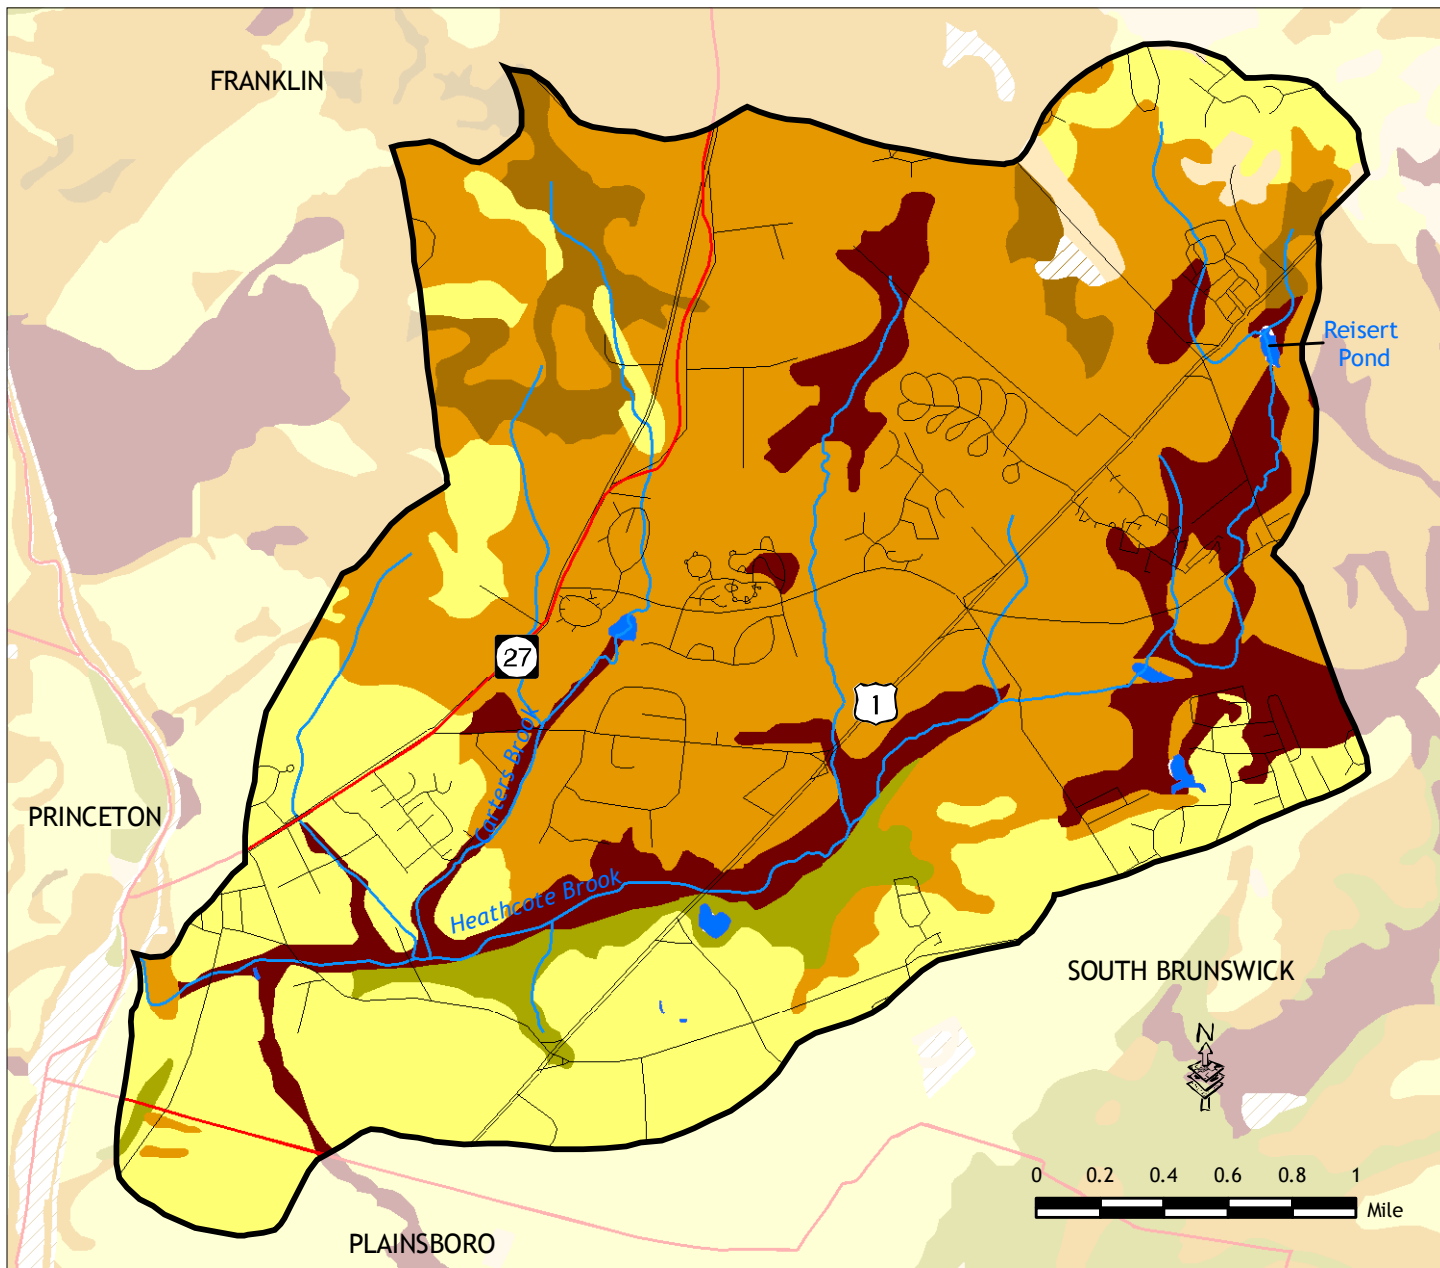
Figure 11: Hydrologic Soil Groups in Heathcote Brook Watershed

Based upon their various compositions, soil series have varying degrees to which they can be infiltrated by water. Their ability to drain water, especially from precipitation, is evaluated and reported as the hydrologic soil group. Much of the Heathcote Brook Watershed is classified as hydrologic soil group C, covering 3,001.4 acres out of a total of 5,854.7 acres (51.3%) in the entire watershed (Figure 11). Hydrologic soil group C represents soils with a slow infiltration rate and, therefore, a high surface-water runoff rate and is representative of the moderately fine-textured soils seen in the Piedmont Physiographic Province. This hydrologic soil group underlies much of South Brunswick and Franklin Townships in the Heathcote Brook Watershed (Figure 11).

The second most common hydrologic soil group in the Heathcote Brook Watershed is group B, representing moderate infiltration rates and moderate runoff rates (Figure 11). Approximately 28% of the watershed, or 1,655 acres, is underlain by hydrologic soil group B with moderately coarse-textured soils. Agricultural areas tend to be underlain by group B soils. The hydrologic soils in group B are found primarily along the southeast and southwest borders of the Heathcote Brook Watershed and do coincide with current or past agricultural areas (Figure 11).
