CHARACTERIZATION AND ASSESSMENT OF THE HEATHCOTE BROOK WATERSHED

Cover Photo: SBMWA bacteria sampling Site HCB7 where Heathcote Brook crosses Mapleton Road in South Brunswick Township

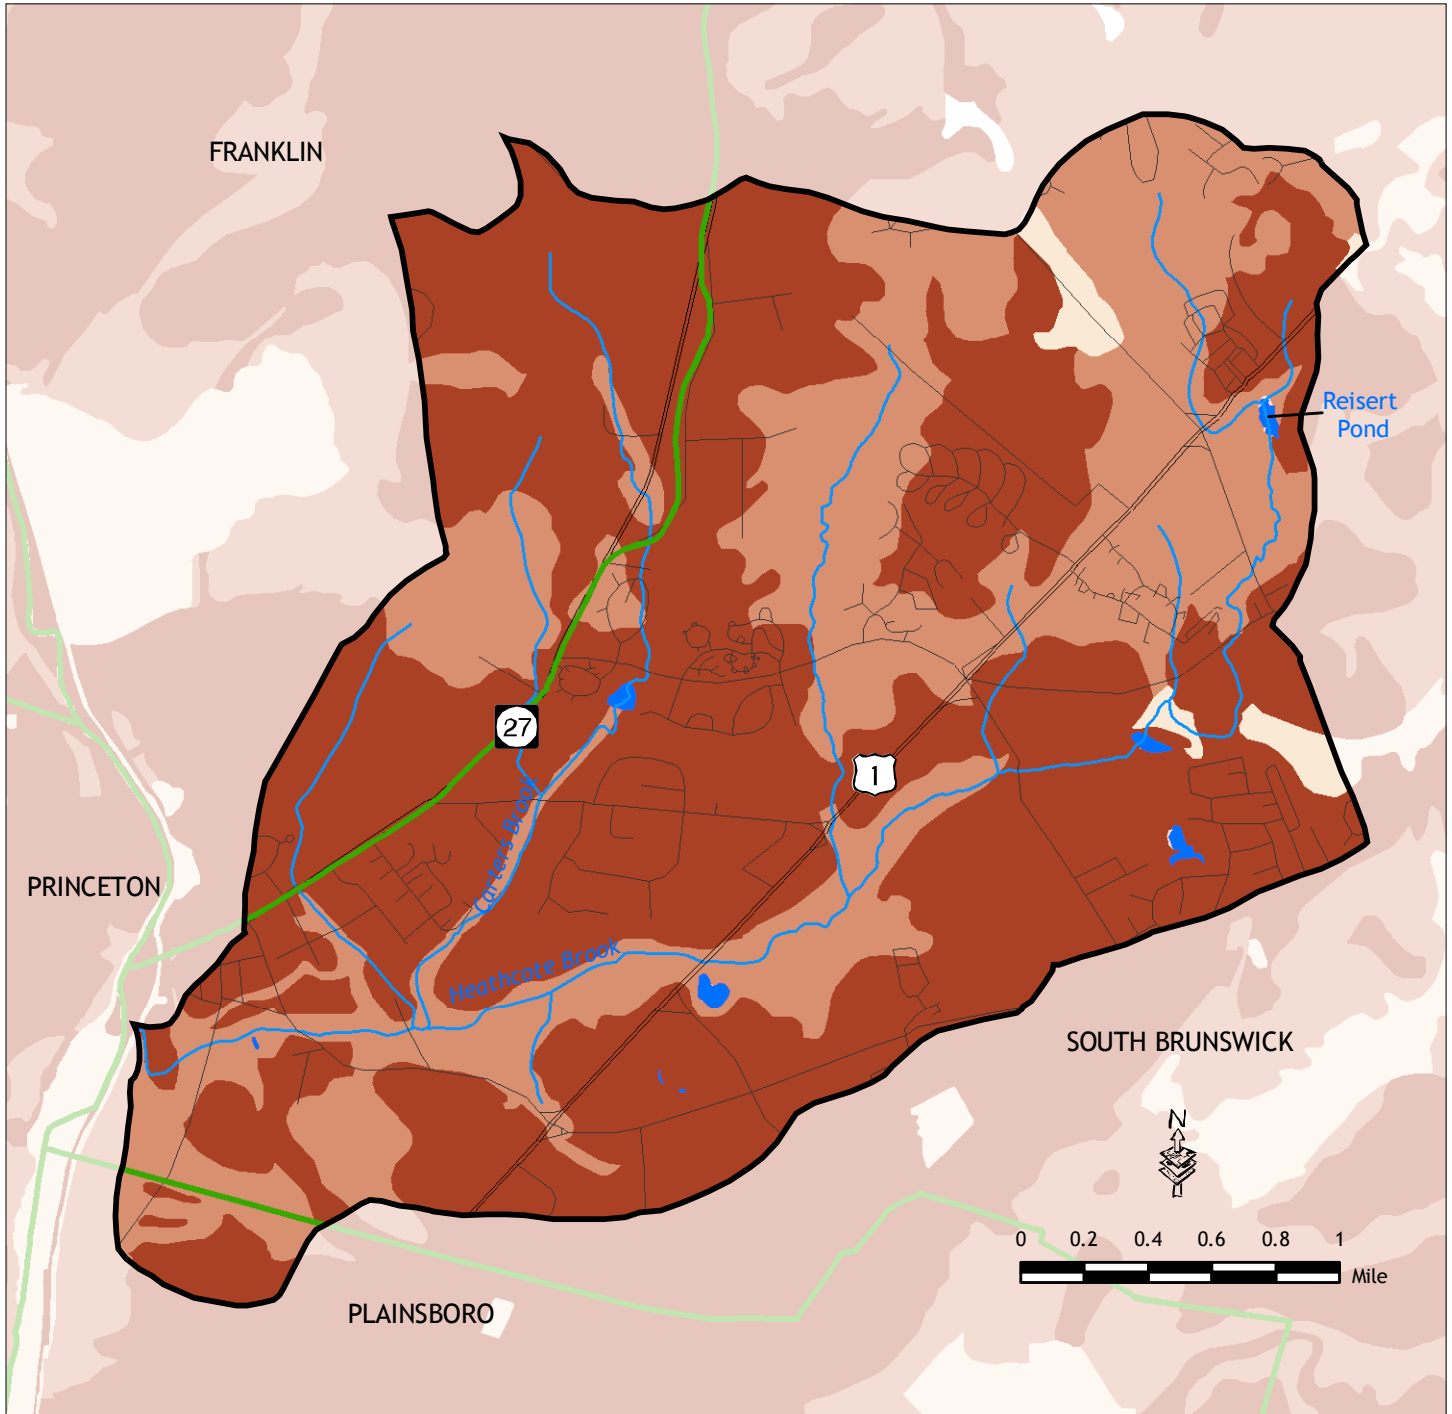
Figure 12: Soil Erodibility in Heathcote Brook Watershed

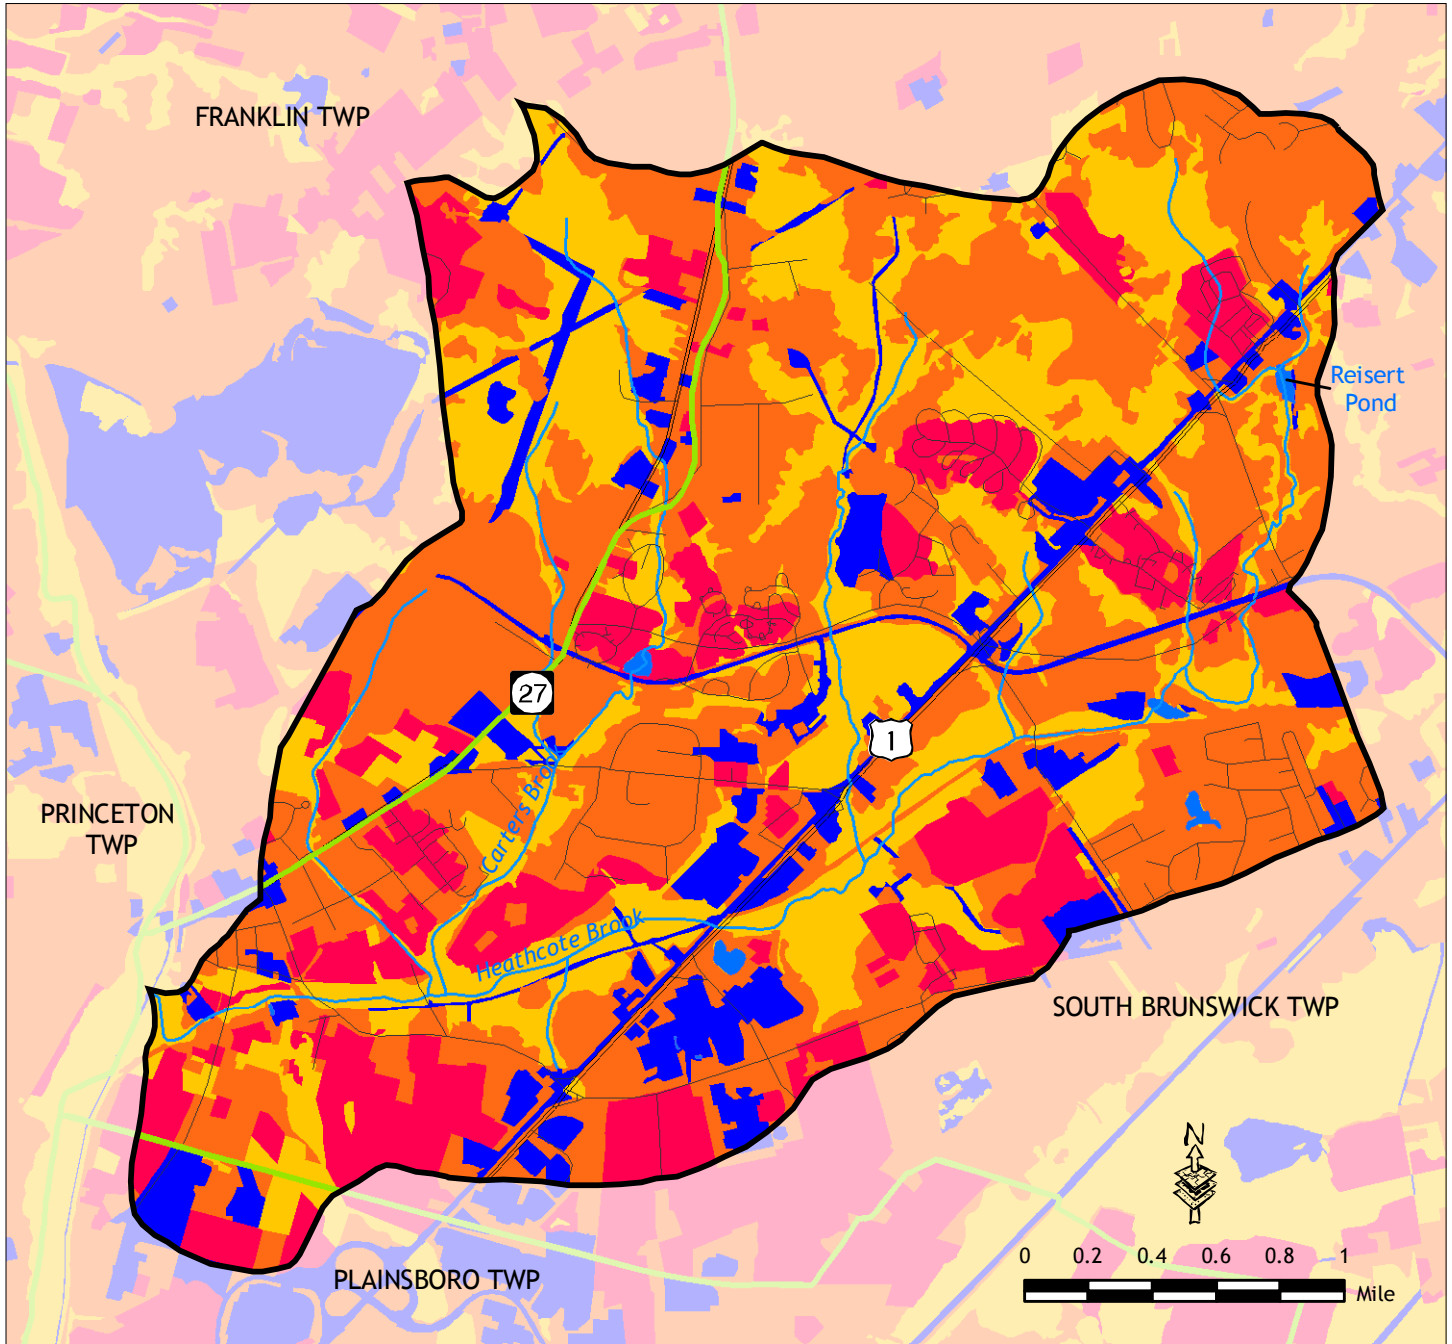
Figure 27: Nonpoint-Source Nitrogen Loadings in Heathcote Brook Watershed

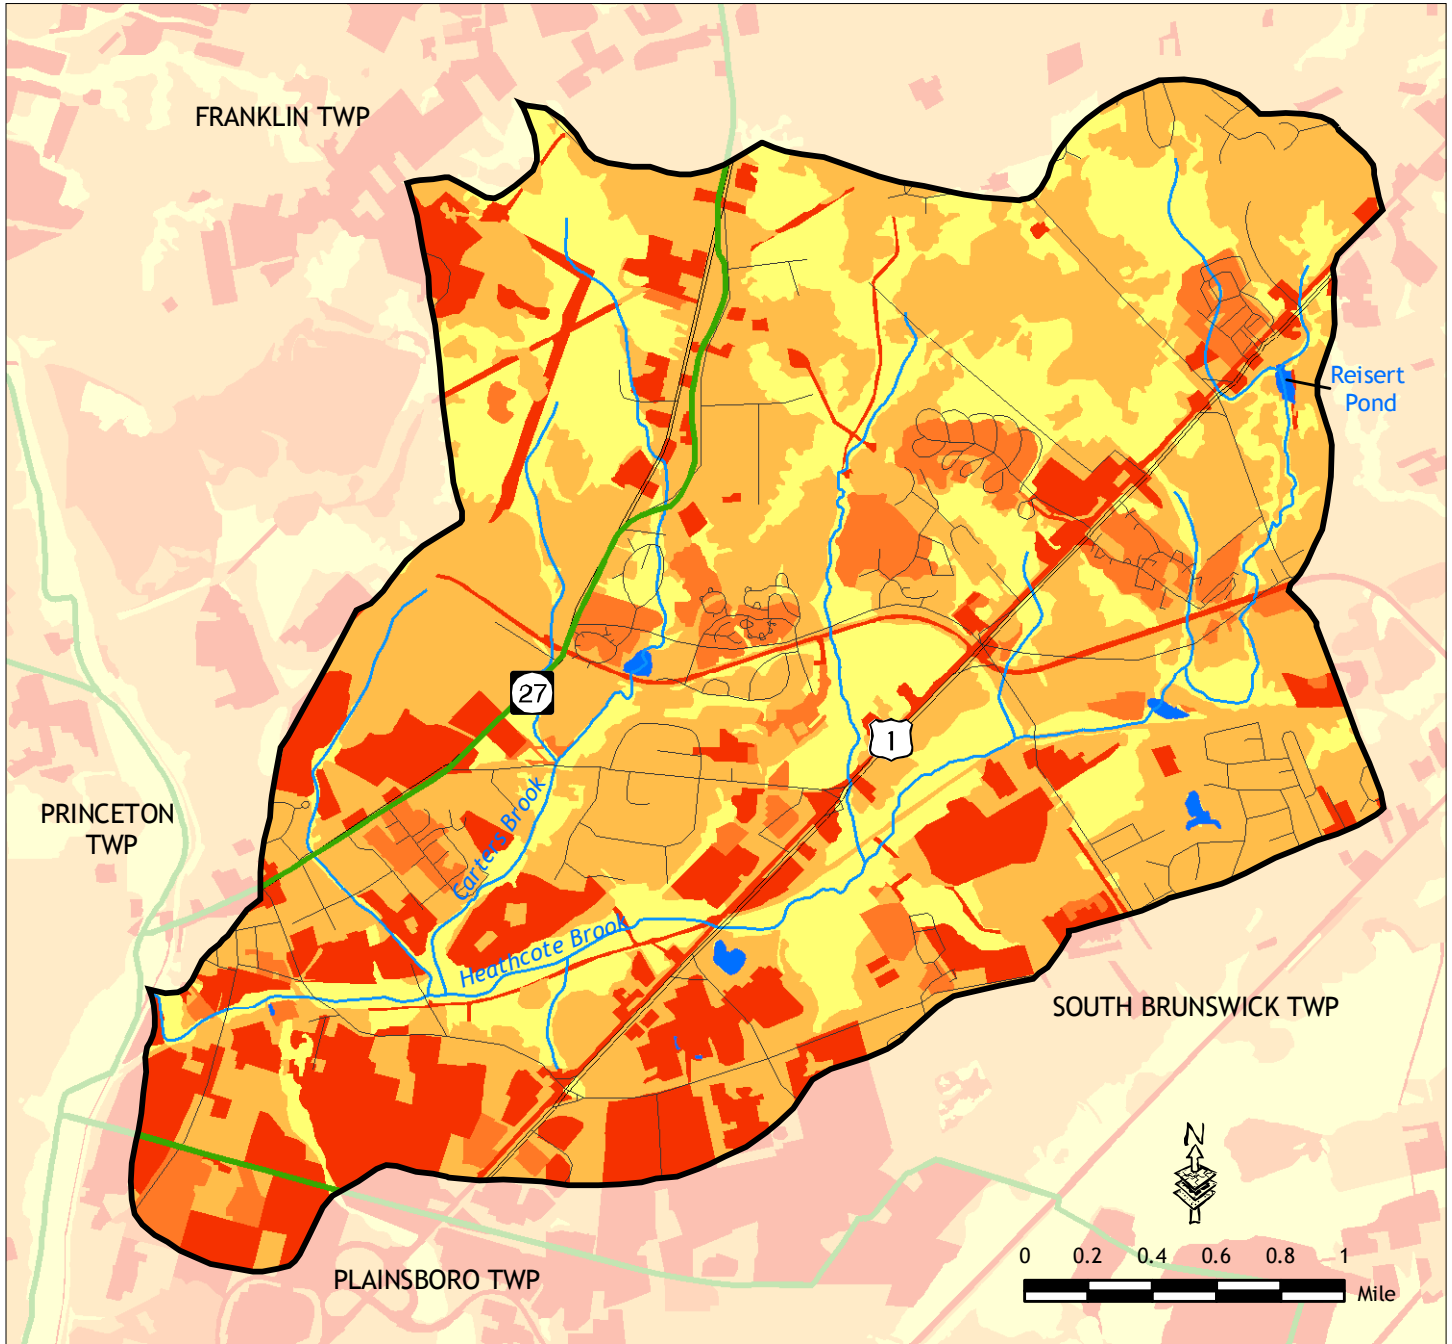
Figure 28: Nonpoint-Source Phosphorous Loadings in Heathcote Brook Watershed

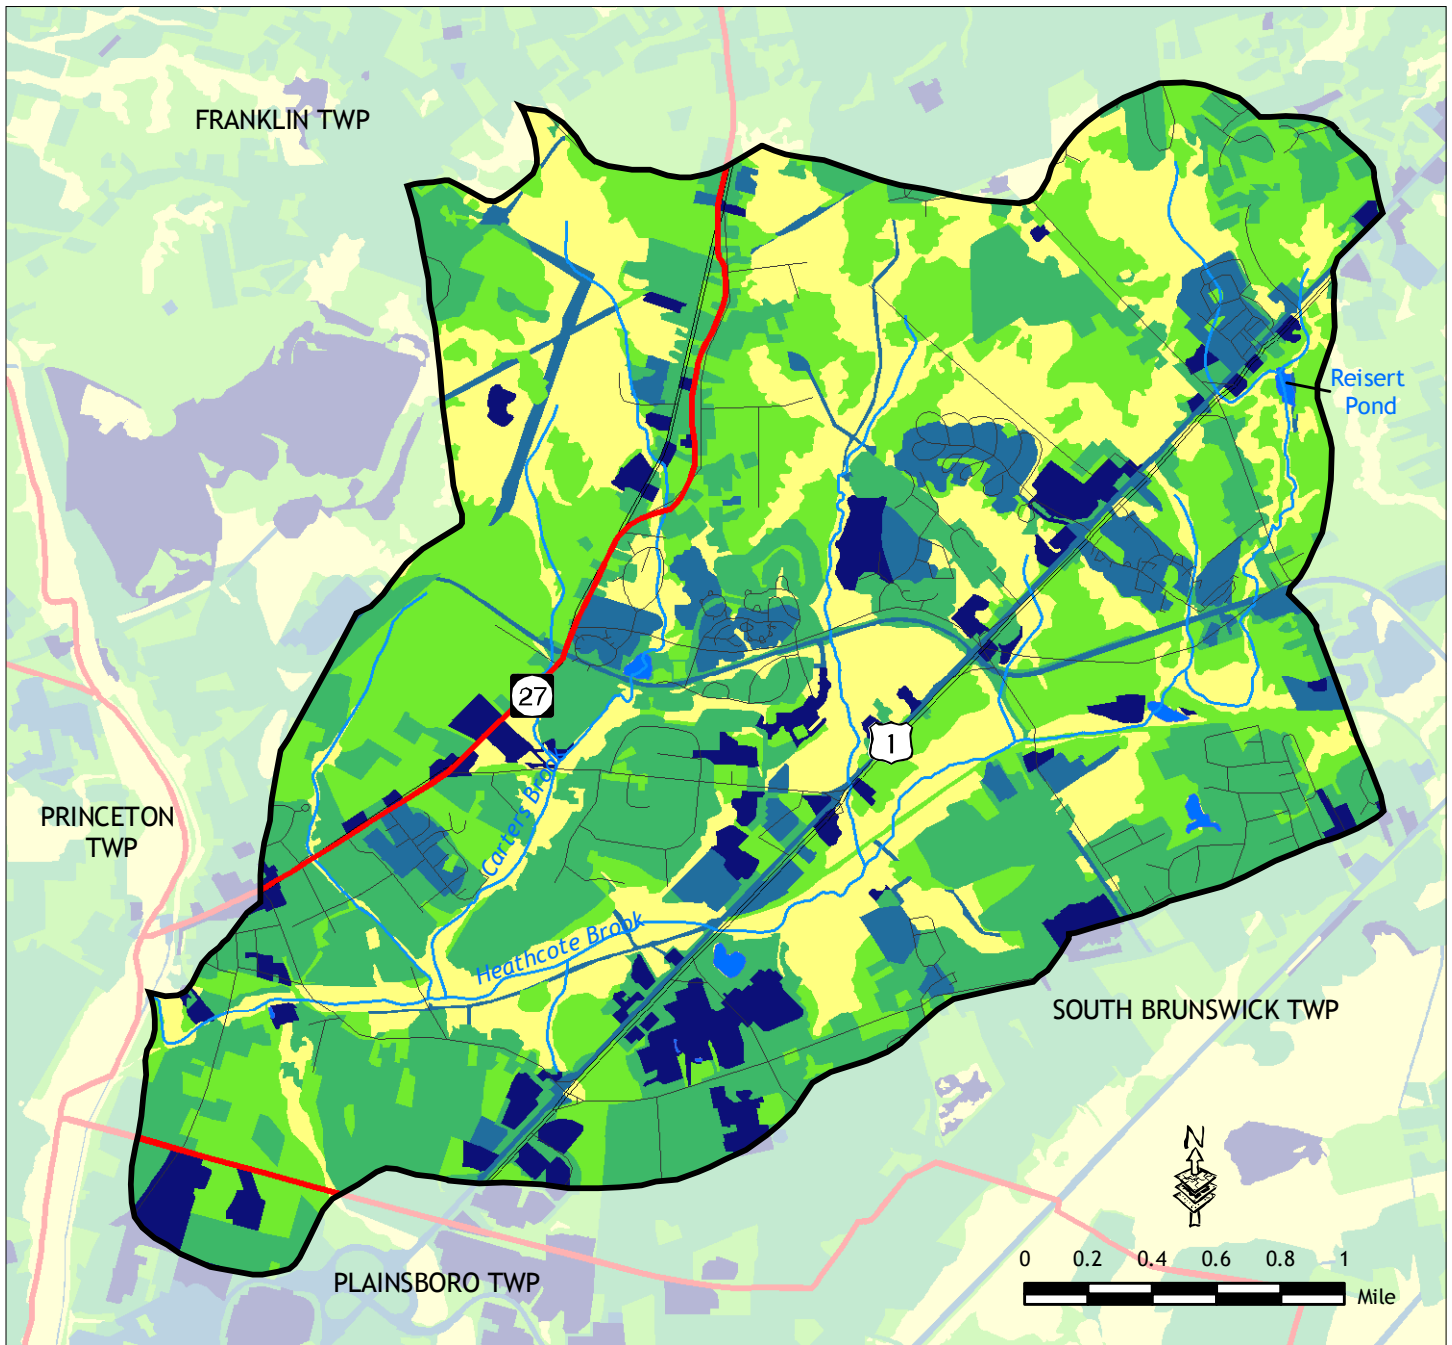
Figure 29: Nonpoint-Source Total Suspended Sediment Loadings in Heathcote Brook Watershed
