CHARACTERIZATION AND ASSESSMENT OF THE ROCKY BROOK WATERSHED

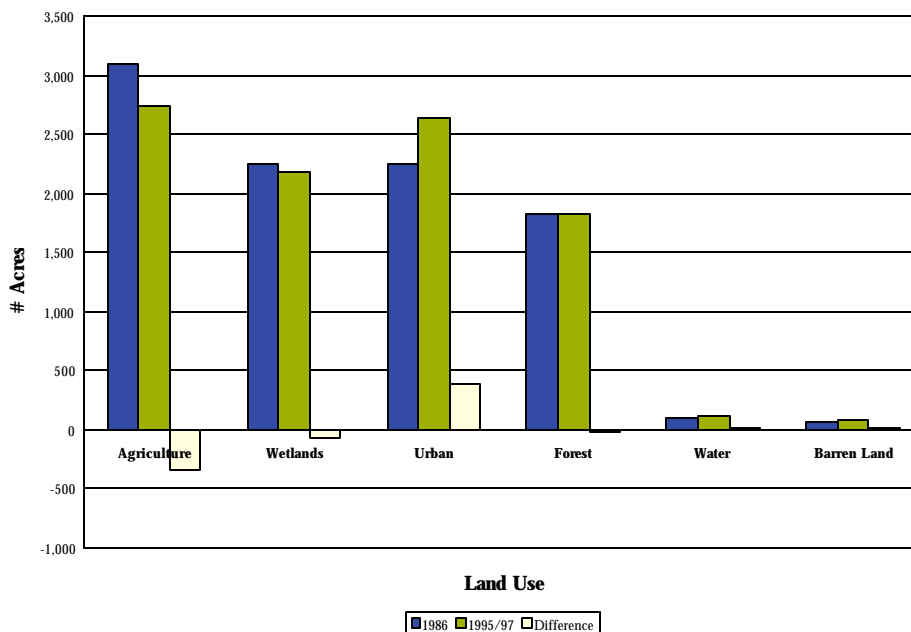
Graph 4: Changes in acreage of land uses in the Rocky Brook Watershed from 1986 to 1995/97.

Source: NJDEP Land Use/Land Cover Data 1986 & 1995/97. Negative percent changes represent a loss in acreage while positive numbers represent a gain in acreage.

The information for land use comes from the NJDEP land use/land use cover data from 1986 and 1995/97, but much development has occurred within the last seven years. Forests, agriculture, urban/developed land and wetlands will be discussed in more detail as they make up the majority of land usage in the Watershed. The remainder of the land use in the watershed is made up of either water (121.0 acres, or 1.3% of the Rocky Brook Watershed) in the form of streams, lakes, ponds, reservoirs and other waterbodies, or barren land (89.2 acres, or 0.9% of the Rocky Brook Watershed) as developing land, quarries and mines (Graph 4 and Graph 5).

In the Rocky Brook Watershed, land use has changed dramatically in the years between 1986 and 1995/97, as there has been a gain in urban areas and a loss of primarily agricultural land. Between 1986 and 1995/97, the landscape draining to Rocky Brook has changed due to shifts in land use as

Since 1986, there has been a minimal loss of 0.6% forested land (Graph 5). In 1986, over 32% of the Watershed, or 3,087.8 acres, was forested (Graph 4 and Graph 5). In 1995/97, approximately 29% of the Watershed, or 2,745.9 acres, was covered with forests (Graph 4 and Graph 5). The majority of the woodlands are found in the southeastern portion of the Rocky Brook Watershed (Figure 13). Millstone Township remains heavily forested and contains this Watershed's headwaters (Figure 13).

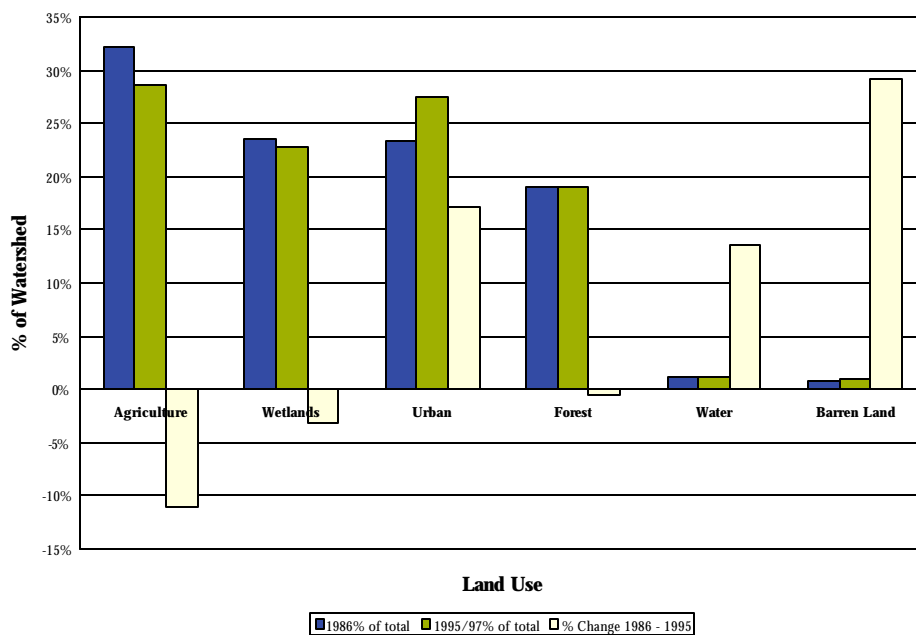
Graph 5: Changes in percent of total watershed area of land uses in the Rocky Brook Watershed from 1986 to 1995/97.

Source: NJDEP Land Use/Land Cover Data 1986 & 1995/97.

Negative percent changes represent a loss in acreage while positive numbers represent a gain in acreage.

Of special note is the increase in barren lands within the Rocky Brook Watershed. Between 1986 and 1995/97, there was a 29.2% increase, but barren lands make up a very small percentage of the entire Rocky Brook Watershed (0.9% in 1995/97) (Graph 5). This represents a temporary condition, as the increase was most likely due to clearing of land in the process of becoming part of the developed or urban land use category.

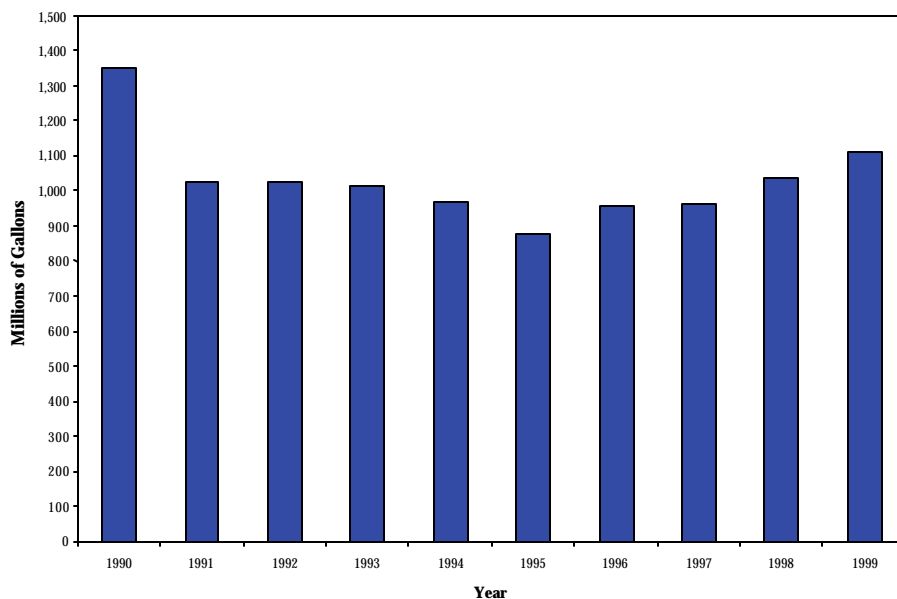
Graph 6: Total permitted water withdrawals in the Rocky Brook Watershed in millions of gallons per year (mg).

According to NJDEP data, water use in the Rocky Brook Watershed is primarily to supply the residents with drinking water, as the largest water withdrawals are by the East Windsor Municipal Utilities Authority (EWMUA), Hightstown Water Department, and private wells (Table 6). The largest water user is the EWMUA, which withdrew 5,696.2 million gallons between 1990 and 1999, representing 55.2% of all water withdrawals in that time (Table 6). It is important to note that the EWMUA is supplying water for the entire township of East Windsor and not just that portion in the Rocky Brook Watershed.
